Building Pressurization Can Affect Possibility of Mold Growth

The following case studies demonstrate the various ways that forced-air systems can significantly affect building pressures. In each case, the authors were contacted to determine the cause of mold growth on interior drywall. Also, in each case, mold growth was determined to be caused by moisture accumulation in the drywall, primarily from the uncontrolled flow of outside air into the building envelope.

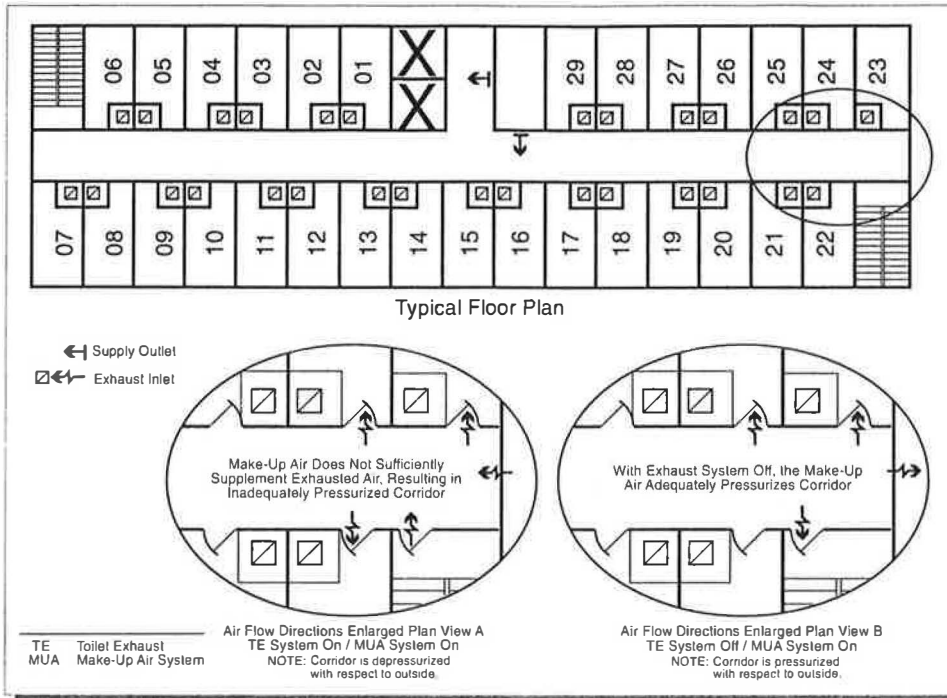
As shown in Figure 1, the airflow directions were consistent with the pressure measurements. Under normal operating conditions, airflow was from the exterior wall into the corridor and from the stairwell into the corridor. When the toilet exhaust system was turned off, airflow reversed, indicating that the makeup air system was pressurizing with respect to the outdoors and the stairwell.

Figure 1 — Despite air balance measurements to the contrary, the HVAC system was not properly pressurizing a multistory hotel in Florida.

This building satisfied typical HVAC commissioning requirements. Airflow volume measurements indicated that the HVAC systems were performing according to their design intent. In fact, according to the commissioning procedure, the forced-air systems should have slightly pressurized the building as more air was being supplied than removed. However, pressure measurements indicated that the forced-air systems were directly affecting all the building cavities and depressurizing the entire building with respect to the outside.

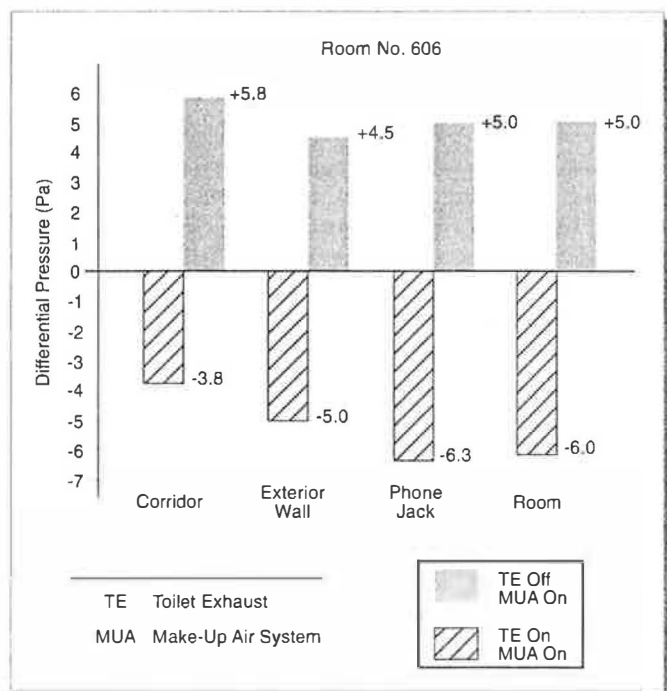
Figure 2 — In case study 1, the average room boundary component pressures were negative with respect to outside under normal operating conditions, causing air to be drawn into the wall system.

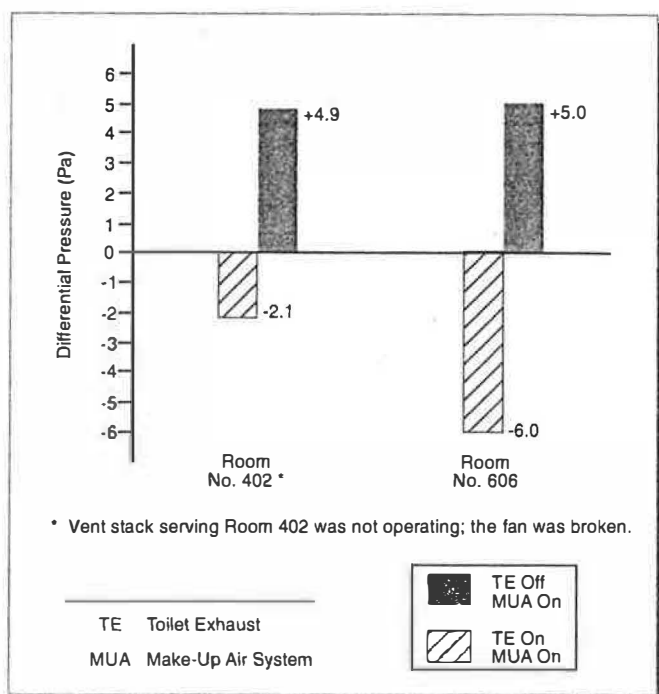
The pressure relationship between the interior and the exterior of the building was reversed when the toilet exhaust systems were turned off. For example in Room 606, differential room pressures were reversed from -6 Pascals (Pa) to +5 Pa (see Figure 3).

Figure 3 — Another cause of air leakage into the rooms in case study 1 was that room pressures were negative with respect to outside.

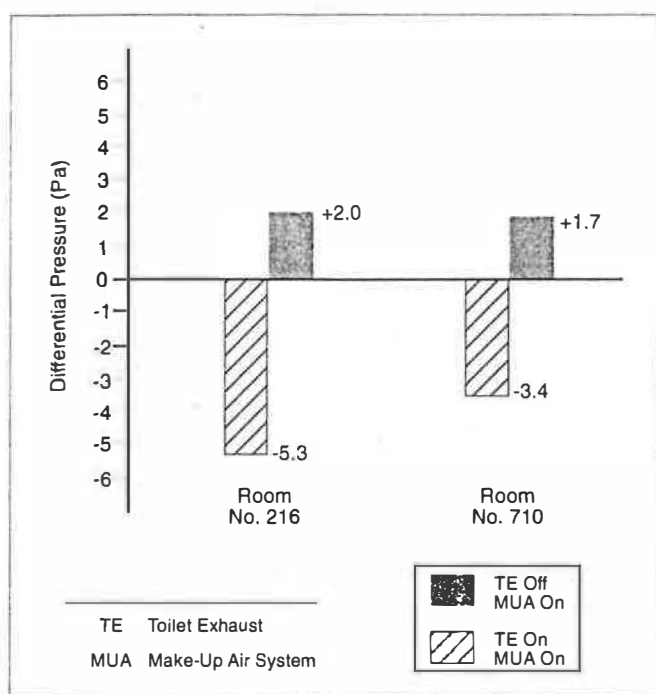
Figure 4 — In case study 2, the average room pressure was negative with respect to outside under normal operating conditions, drawing air into the room.

- The guest room interiors were negatively pressurized compared to the building exterior (see Figure 4)

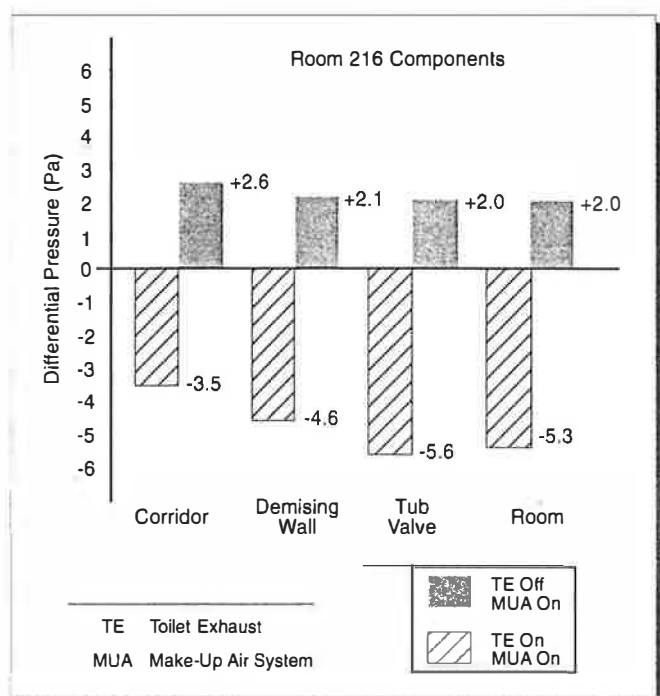
- The guest room wall cavities were negatively pressurized compared to the building exterior (see Figure 5)
- The corridors were negatively pressurized compared to the building exterior (see Figure 5)

Figure 5 — Negatively pressurized wall cavities also caused air to be drawn into the rooms in case study 2.

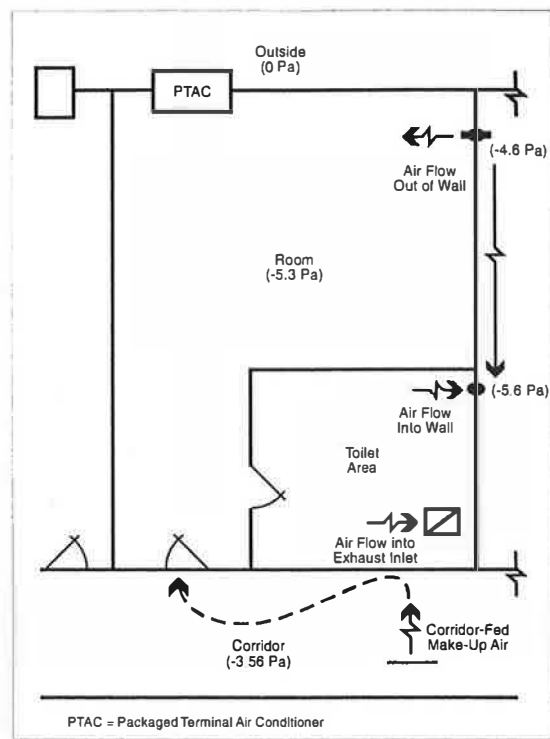
Airflow visualization of the tested rooms supported the pressure measurements (see Figure 6). Furthermore, airflow direction indicated that the toilet exhaust system was directly affecting the demising wall cavity pressures and that the airflow direction was from the rooms to the plumbing chase. Even in the toilet area where the exhaust inlet is located, airflow direction was predominantly from the toilet area to the wall cavity. The pressures also indicate that air entering the exterior building envelope is likely to travel down the demising wall toward the plumbing chase where pressures are lowest.

Figure 6 — In case study 2, airflow visualization showed that air was entering the exterior building envelope and traveling down the demising wall.

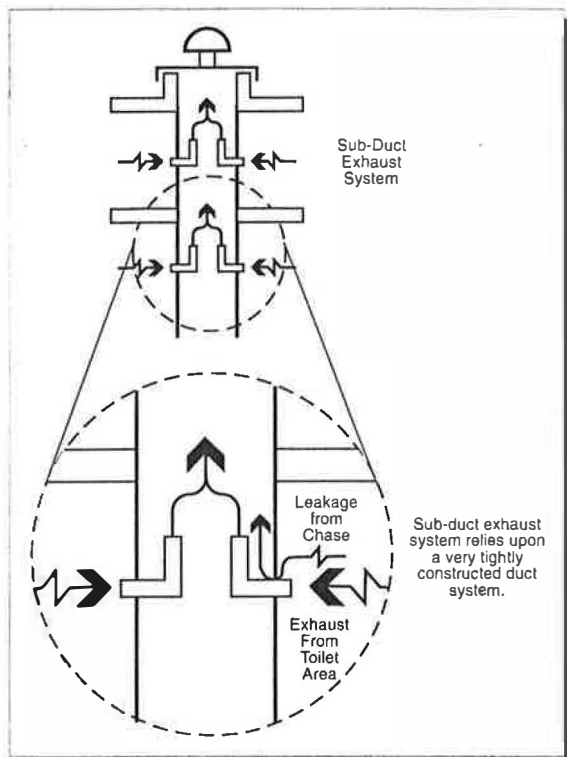
Under these conditions, the toilet exhaust systems not only depressurize the rooms, but also directly depressurize the plumbing chase and adjacent wall cavities because of ductwork leakage (see Figure 7).

Figure 7 — In case study 2, air leakage from the plumbing chase to the central exhaust duct caused the entire chase to depressurize and draw air through the demising walls from outside.

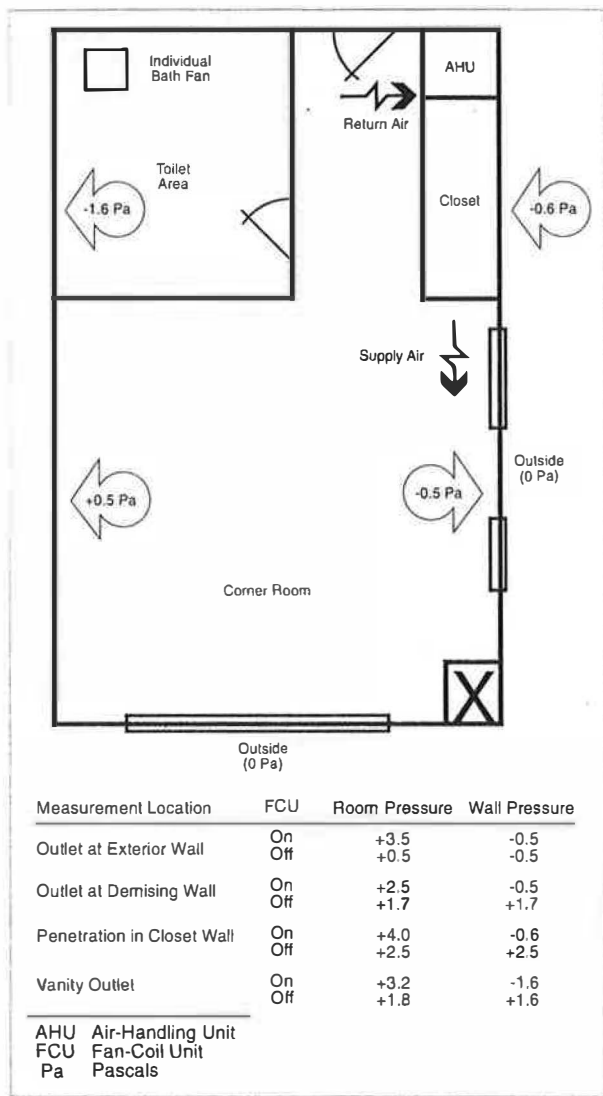
Detailed pressure measurements were taken in several rooms (see Figure 8). For each set of measurements, the outdoor air pressure was used as the reference and was taken with the FCU both on and off. The measurements indicated the room is always positively pressurized with respect to the outdoors; however, the wall cavities are positive only when the FCU is off, and with the exception of one interior wall, all are negative when the FCU fan is on.

Figure 8 — Case study 3 demonstrates that it is possible to have pressurized rooms and a depressurized wall system.

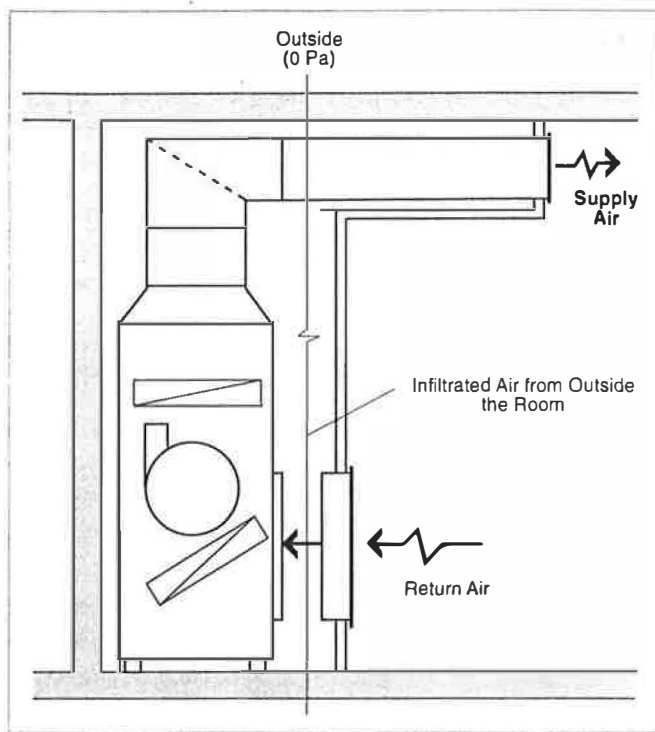
Pressure measurements showed that the FCU was drawing air from outside the room because of the suction pressure at the return side of the FCU (see Figure 9). Pressure measurements also showed that many of the wall cavities and ceiling areas of the rooms were negatively pressurized with respect to the outside while the FCU was on. This was true despite the fact that the room was positively pressurized with

Figure 9 — As demonstrated in case study 3, the return-side leak in the FCU pressurized the room but depressurized the wall systems.
