West Coast R-2000 House: Airtight and Dry After 17 Years

Richmond, BC R-2000 House Case Study

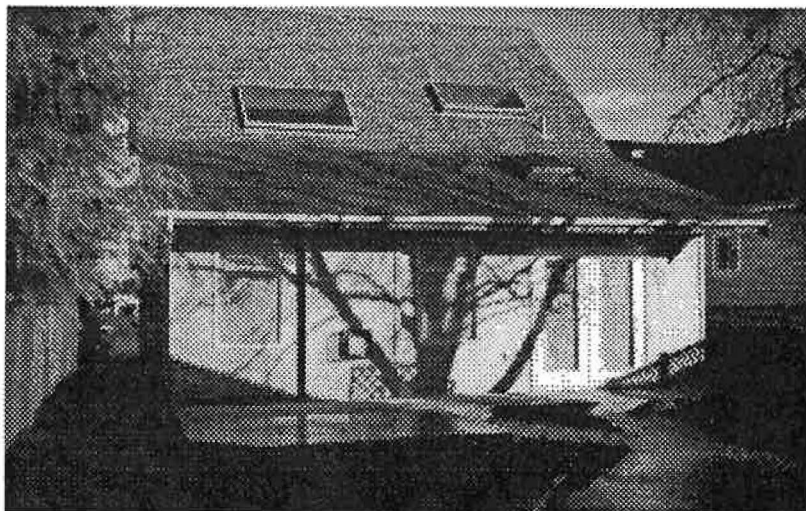
South side of house, after addition.
