CONDENSATION PROBLEMS IN FLAT WOOD-FRAME ROOFS

George T. Tamura, George H. Kuester & Gustav O. Handegord

Division of Building Research

National Research Council of Canada

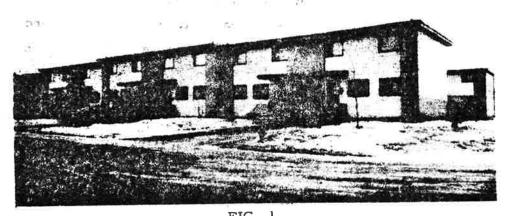
Test Units

The persistence of problems even after attempts to reduce humidities, prompted a questionnaire survey by DBR/NRC in 1968. The survey results indicated that ceiling condensation problems had occurred in 28 of the 122 units; 21 cases in units with flat roofs, 6 in those with low sloped roofs and one case in the units with steeply sloped roofs. This indication that flat roofs were more susceptible to condensation problems was in keeping with a general indication from the housing industry and led to a detailed study of performance and construction features in a sixunit row house within the development (Figure 1).

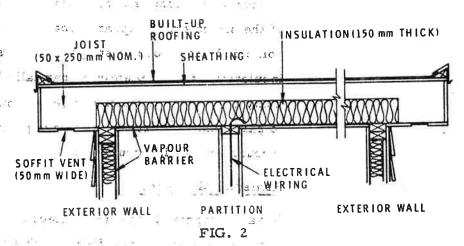
Flat Roof Construction Detail

wallboard on strapping. End walls were of concrete block with wood furring, insulation and gypsum wallboard interior. Details of the roof construction are shown in Figure 2.

space was intended to be continuous and open to the soffit vents at the front and rear of the unit. In a number of joist spaces however, placement of insulation over nailing strips or cross bridging had resulted in blocking of this air space. The polyethylene vapour barrier, although intended to provide a continuous membrane under the insulation, was interrupted by the partition walls since these were used to support the roof joists in the initial erection process. Shrinkage of the top plates after application of the vapour barrier and wallboard, or other difficulties in securing the wallboard at this location, allowed an opening in the form of a crack that connected the interior of the partition to the roof space. Electrical wiring and plumbing services were also carried through these walls, allowing openings to the roof space. At party walls, the space behind furring strips and the masonry itself afforded similar passages of air and vapour movement.

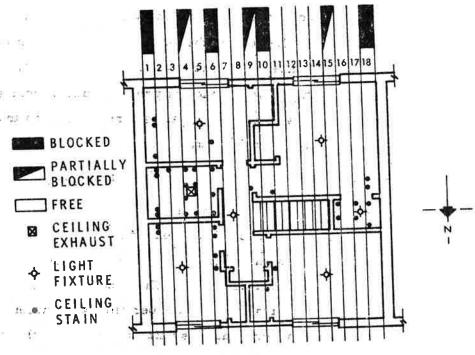
FIG. 3

When these "as-built" details were considered in relation to the pattern of staining that had occurred on the upper floor ceilings of the six units, it appeared that many of the major water stains coincided with those joist spaces where the air space above the insulation was completely or partially blocked (Figure 3). In many cases, the locations of severe staining were also adjacent to partitions or party walls where potential leakage openings through the ceiling could occur.

Location of Blockage in Joist Space and Ceiling Stains in Row Housing Unit

The most obvious approach to solving the roof space condensation problem is to increase the air tightness of ceiling constructions. For new construction, efforts in this direction have been taken in Canada (2). Other changes in practice with respect to application of barriers to air flow in construction operations or relocation of electrical distribution and wiring could be warranted.
