COMMERCIAL APPLICATIONS OF RADON MITIGATION TECHNIQUES

J.G. Davidson

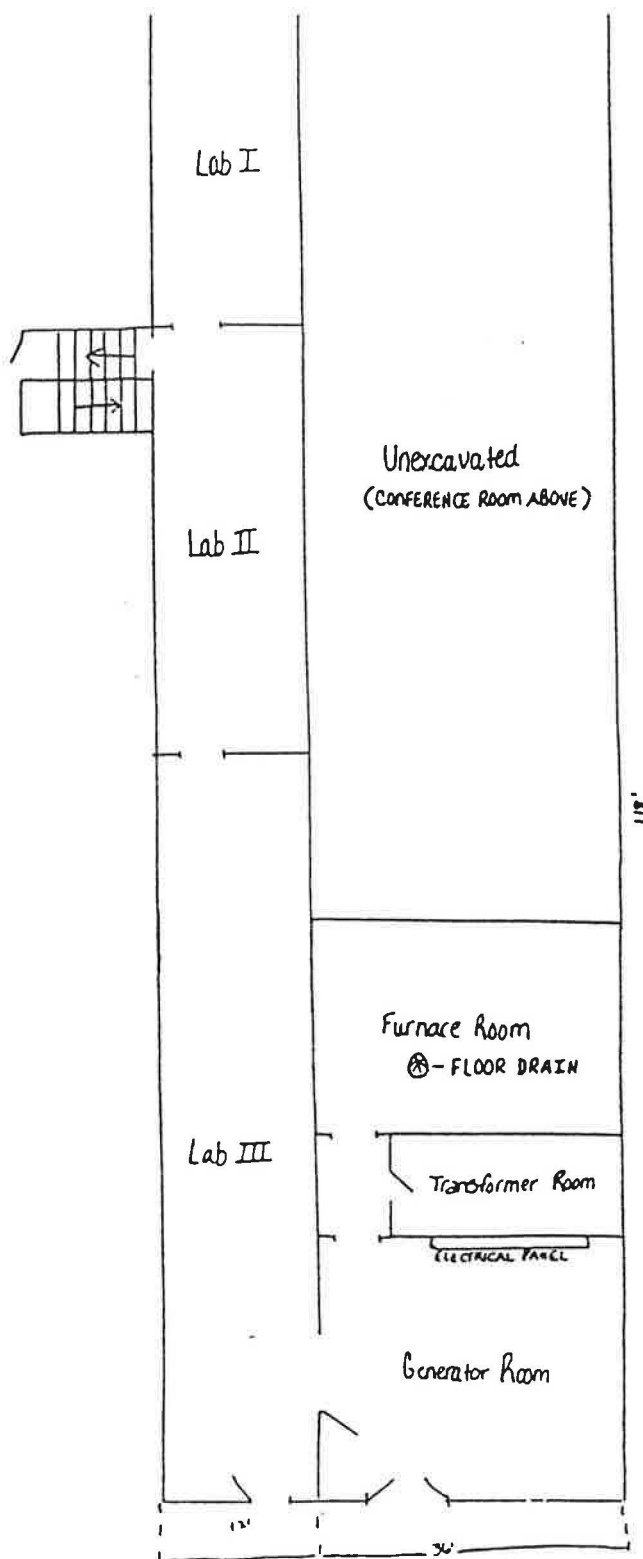
Diagram 1

A two-story building, partially built into a bank, the building was constructed of 12 in concrete block and was completed in 1955. The building was 118 ft long and 36 ft wide. It had 6600 ft² of interior space, the lower level being a lab area having been altered many times, and the upper level being office space. There was also a 1500 ft slab-on-grade conference room. There was no central forced heating or air-conditioning, the heating being baseboard radiation and the air-conditioning consisting of window units. In the lab areas there were no fume hoods. (See Diagram 1.)

Location	Original Reading
Lab I	51.6 pCi/L
Lab II	40.8 pCi/L
Lab III	36.6 pCi/L
Furnace Room	23.1 pCi/L
Generator Room	36.1 pCi/L
1st Floor Conf. Room	22.1 pCi/L

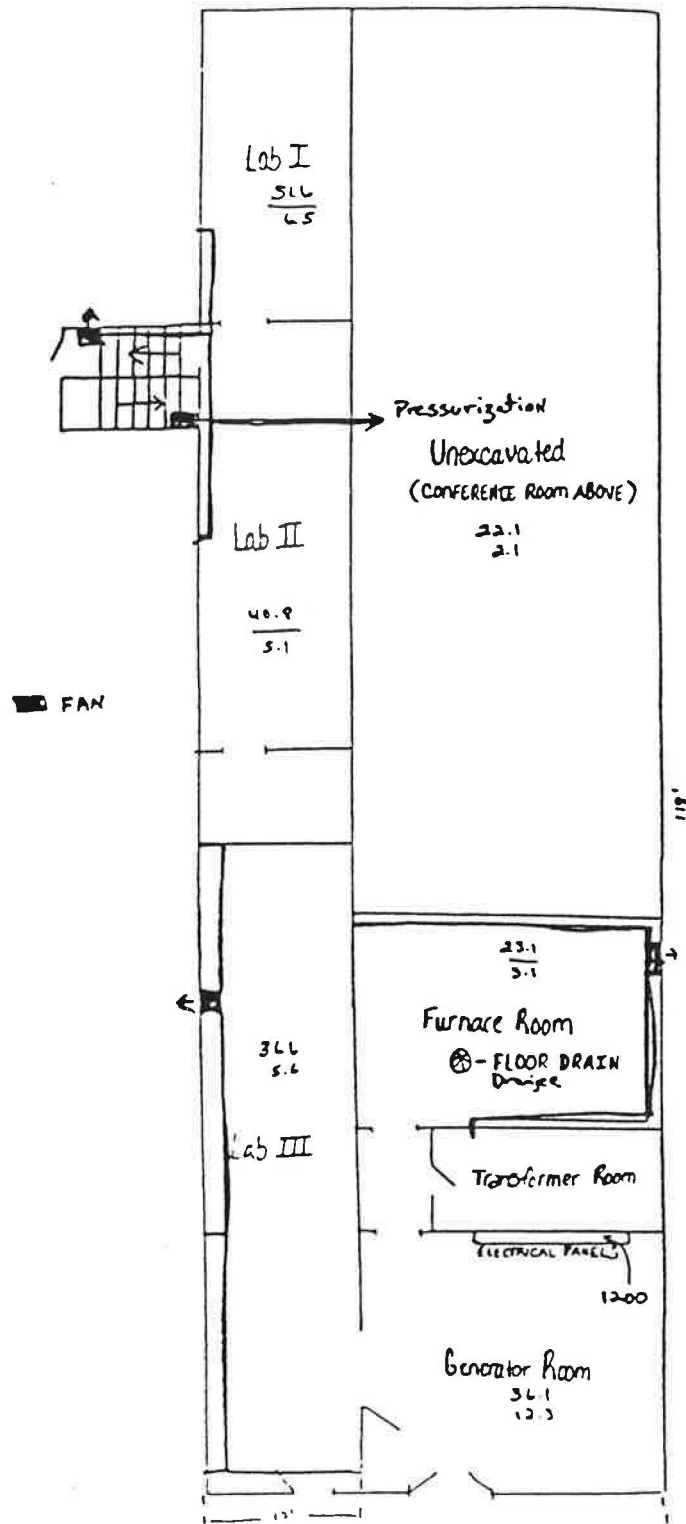
Diagram 2

Shows 3 blockwall suction systems and 1 pressurization system.

Numbers indicate radon levels (in pCi/L) prior to and after remediation.

<i>Location</i>	<i>Reading with System</i>
Lab I	6.5 pCi/L
Lab II	5.1 pCi/L
Lab III	5.6 pCi/L
Furnace Room	3.1 pCi/L
Generator Room	12.3 pCi/L
1st Floor Conf. Room	2.1 pCi/L

vented this from being done. It was decided to install three wall depressurization systems and, as an experiment, a pressurization system was installed for the area under the conference room slab. From the building investigation, it was apparent that openings through the conference room slab were all sealed. If the pressurization system did not work, the second alternative was depressurization. It was hoped that the space could be pressurized with about 10 pascals. Using a micromanometer and a rheostat on the fan, levels were obtained that fluctuated between 8 and 15 pascals on a regular basis.
