MOISTURE PROBLEMS CAUSED BY HYGROSCOPIC BEHAVIOUR OF MATERIALS

R.P.J. van Hees

TNO - Institute for Building Materials and Structures
PO Box 49, 2600 AA Delft, The Netherlands

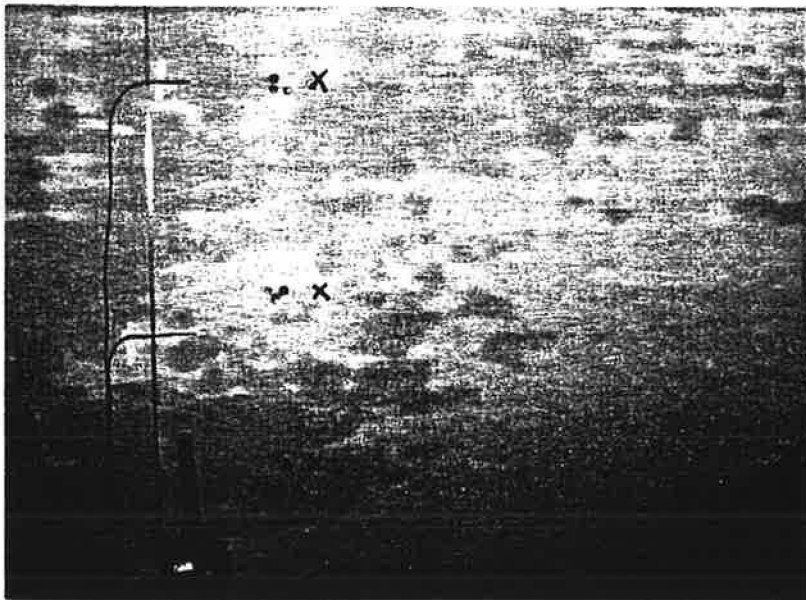
The structure of the walls was brickwork, plastered with a gypsum plasterlayer (thickness 10 to 30 mm) and finished with wallpaper. The load bearing (=founded) indoor walls were covered with visually moist areas, partly just above floor level, giving the problem at least a little bit the appearance of rising damp. On a second view the situation appeared to be more complicated: also on a higher level a pattern of moist and dry zones could be seen (fig. 1).

FIGURE 1. Moist areas on a plastered indoor brick wall; the spots where samples were taken are indicated by "x"

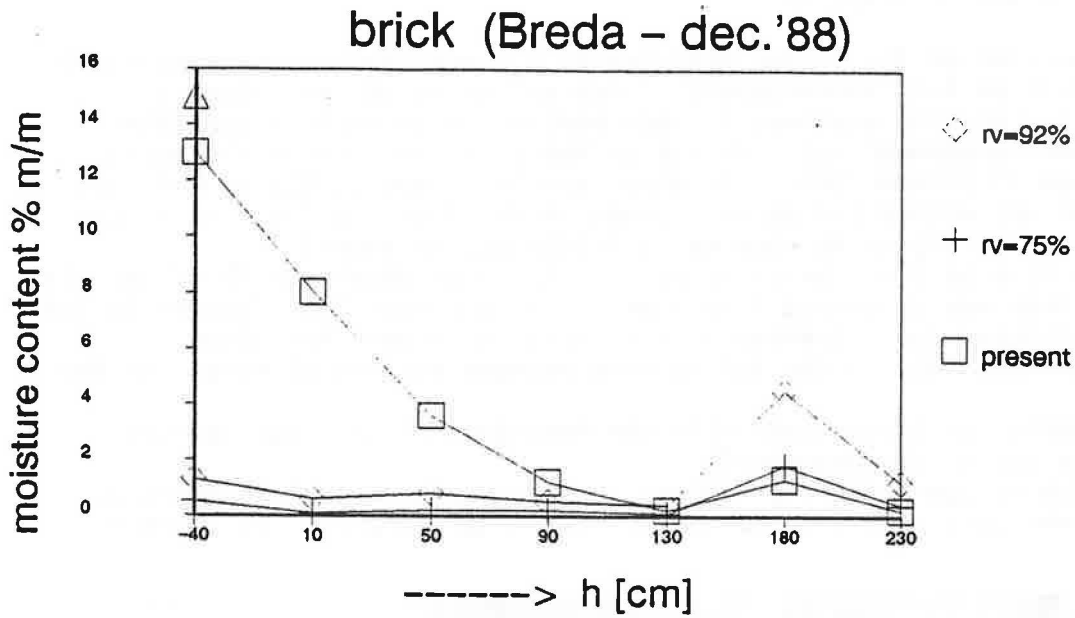
To investigate the first hypothesis, grit samples were taken from the plasterlayer and the underlying brick. In this way the moisture distribution over the height of the wall was determined. The same samples were used to determine the uptake of hygroscopic moisture at RH's of 75 and 92% respectively. The results are shown in fig. 2a and 2b. From the course of the moisture content, in relation to the hygroscopic uptake the existence of rising damp up to a height of 1.00 m in the center of the wall can be concluded. For the plasterlayer this height is only 0.50 m.

FIGURE 2a. Moisture distribution over wall height (brick) and hygroscopic moisture uptake

- up to a certain height there is still rising damp involved.
- On higher levels the moist spots cannot be attributed to rising damp.

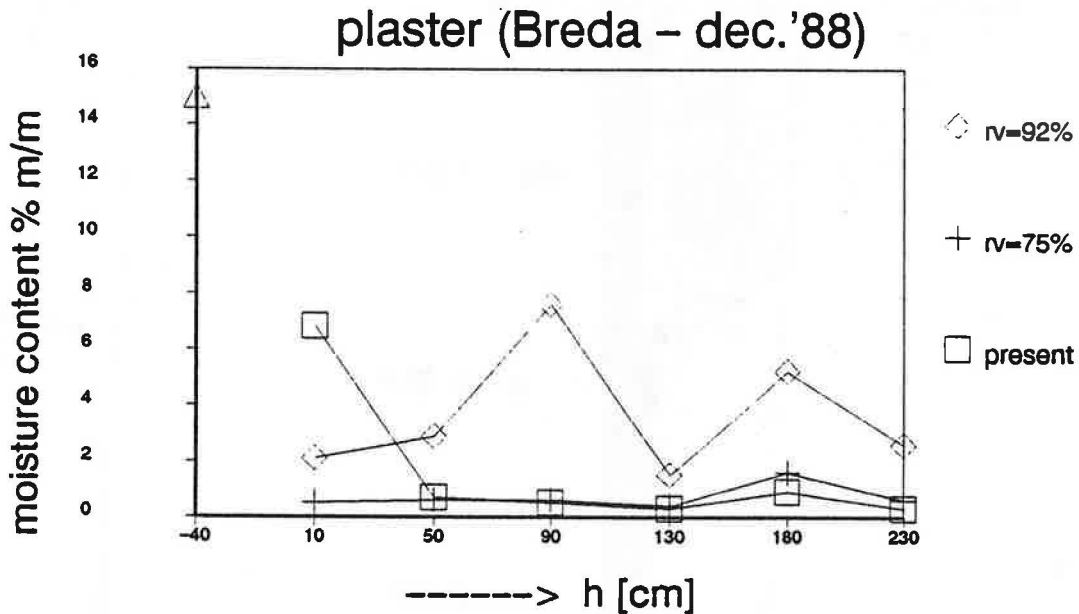
FIGURE 2b. Moisture distribution over wall height (plaster) and hygroscopic moisture uptake

Especially the hygroscopic behaviour of the plaster is most remarkable. The peaks in the hygroscopic curve of 92% RH do correspond to the

"moist" areas in practice !

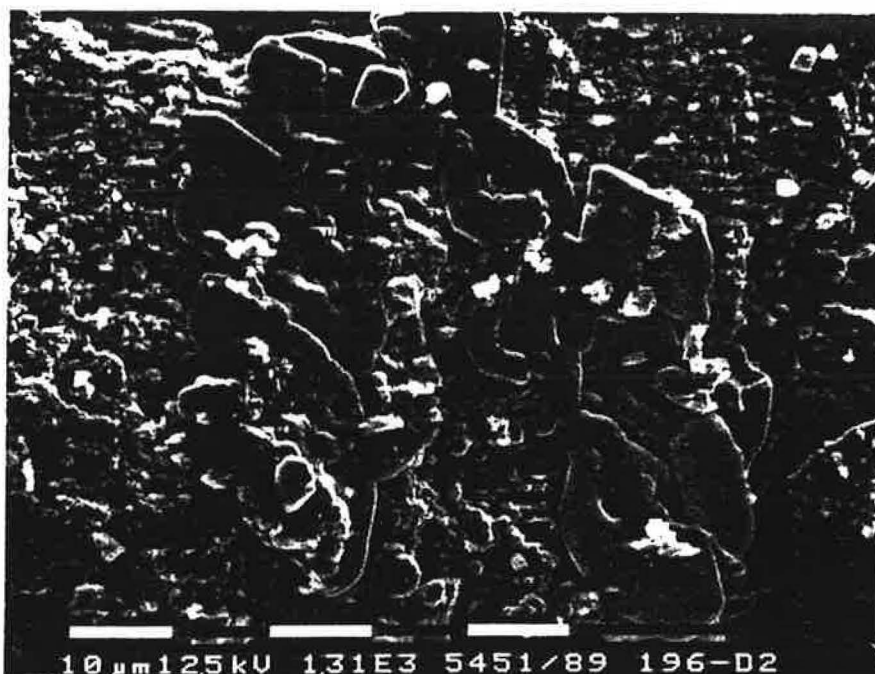
The SEM/EDAX technique was used to detect type and structure of the salt crystals in some of the thin samples. Several crystals of Sodium salts were found near the surface; fig. 4 shows salts embedded in the gypsum of the material surface. It was established that no chlorides or sulphates were involved. We suppose that the salts found are nitrates. Alas SEM/EDAX is not able to detect nitrates.

FIGURE 4. SEM/EDAX picture showing (Sodium) salt crystals on the plaster surface
