INVESTIGATION OF CRAWL SPACE VENTILATION
AND
MOISTURE CONTROL STRATEGIES
FOR B.C. HOUSES
Final Report

Research Division
Canada Mortgage and Housing Corporation

Sheltair Scientific Ltd.
#2 - 3661 W. 4th Ave.
Vancouver, B.C. V6R 1P2

June, 1991

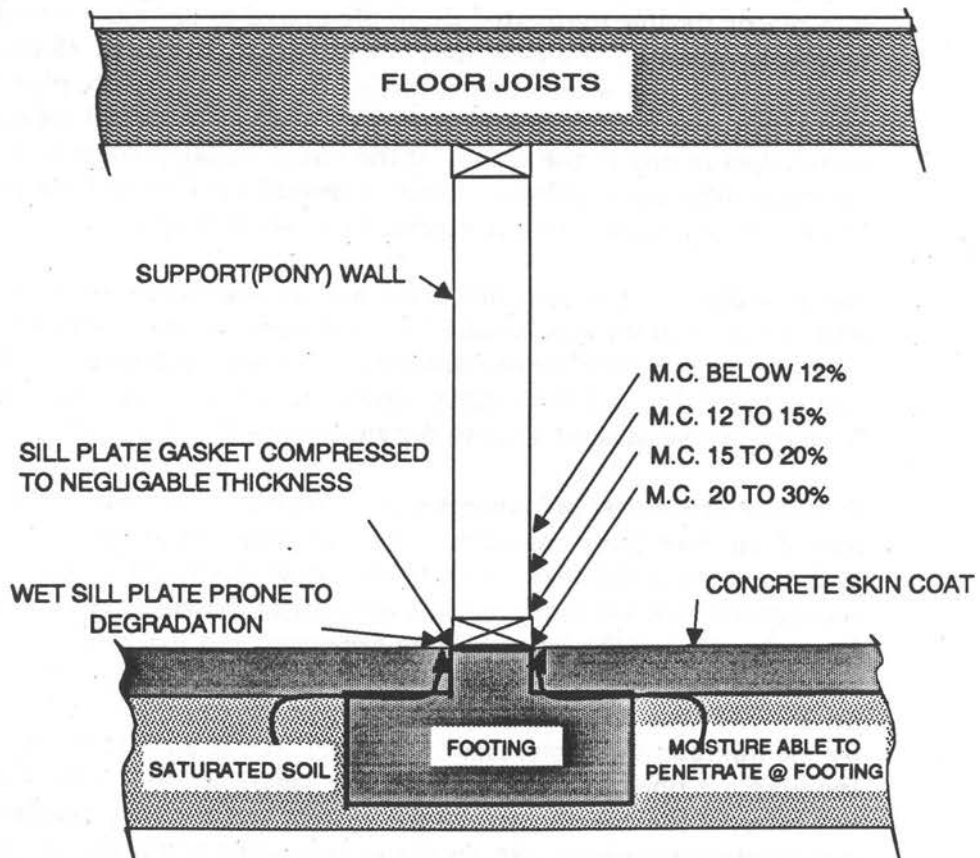
Figure 4: Typical Moisture Gradient for Slab Level Support Walls

The absence of concrete curb walls for interior support walls may cause structural damage in many houses built in this manner. Three of the houses visited had support walls built at floor level and of these, two recorded wood MC's of greater than 20 % at the sill plates. Moisture moving horizontally through the floor slab saturates the sill plates. Figure 4 illustrates the typical moisture gradient of sill plates resting on a slab located in region where the soil may be saturated.

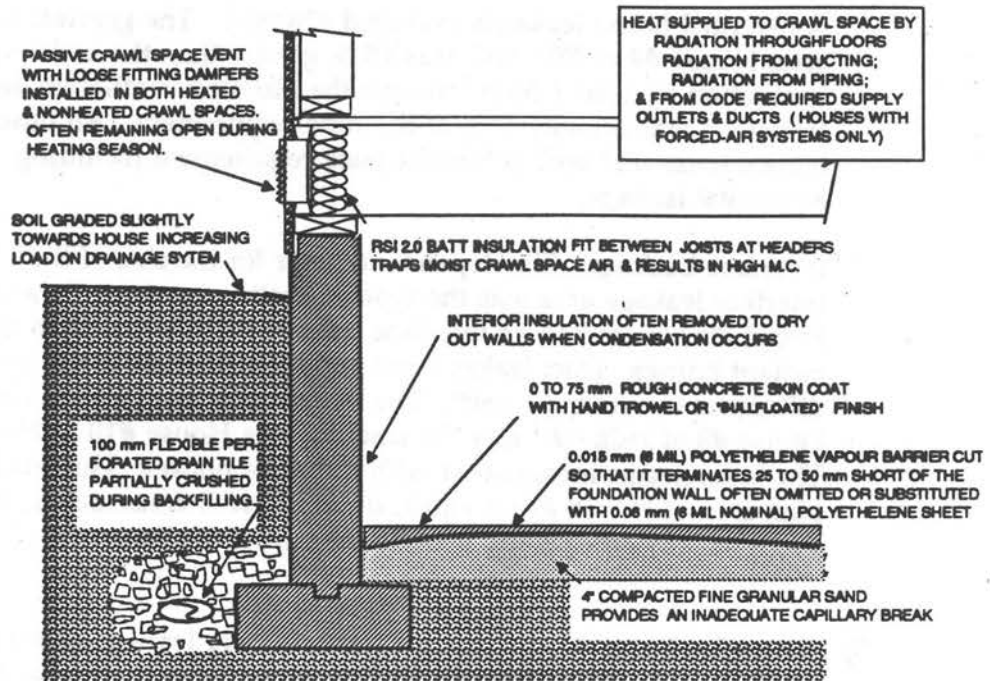
Figure 5: Conceptual Drawing of Crawl Space Construction Showing Typical Problems Encountered

Extensive cracking of the skin coat was common to all houses. House # 6 and House #8 slabs were most severely cracked. These were also the driest crawl spaces. In House #8, examination of a long 12 mm wide crack in the slab permitted a visual inspection of the poly vapour barrier. The integrity of the polyethylene had been maintained, despite the cracking of concrete.

Perimeter Walls: Poorly applied rigid insulation leaves more opportunity for condensation along concrete walls above grade, especially if humidity is high as in the three NHWP problem houses, where insulation was removed to dry out the concrete surface. A good practice for insulation of foundation walls was used in House #5, where insulation was applied from the outside at grade level. Insulation in the other nine houses was applied from the interior, typically with 35 to 50 mm expanded polystyrene board. In most cases the insulation extended from sub floor level to approximately 700 mm or 300 mm above the crawl space floor. The minimum requirements are for insulation to extend to below the frost line, which in the lower mainland is 300 mm below grade. The common method of fastening insulation to the walls is to use 2 concrete nails per 60 cm X 240 cm sheet. In some of the houses an adhesive was also used in combination with the fasteners. In House #8, no adhesive had been used and the sheets had warped leaving 25 to 50 mm air spaces behind the rigid insulation - reducing the effectiveness considerably.

Poor Duct Construction: In House #4, abnormally high fuel costs for the heating season were reported. A cursory investigation revealed that this was probably related to crawl space heat loss. Crawl space vents were left open during the winter bringing a supply of cold air into the very leaky return air plenum, causing high infiltration during furnace on cycles. Duct tape used to seal the duct work had failed in many areas.
