Housing—renovation

New method of renovating wall sills damaged by mould

RELIABLE AND FOOLPROOF RENOVATION OF SILLS SATISFIES TENANTS AND COMBATS 'SICKHOUSES'

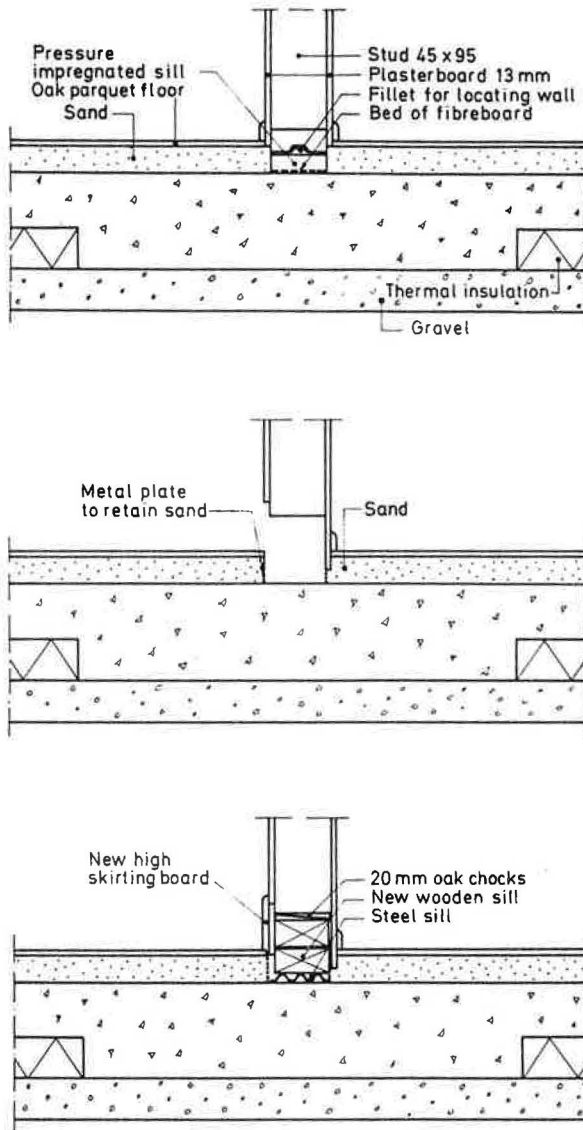
The smell of mould was attributable to faults and deficiencies in the join between the partition wall and the concrete slab (the floor placed directly on the ground with thermal insulation underneath). The concrete slab under this partition wall is reinforced but lacks thermal insulation, which would also give protection from vapour transference from the ground. Moreover the concrete slab does not have a moisture barrier under the partition wall. The wall sill, with strips of fibreboard under it, is therefore in direct contact with the concrete slab (Fig. 1). A critical level of moisture had been reached in the sills. This moisture was transferred from below both in the form of vapour and by capillary action. Both the sills and the fibreboard strips had been infected with the smell of mould. Visible mould was found mainly on the fibreboard strips. The high moisture ratio in the sills encourages the growth of mould fungi. In this case mainly *Aspergillus* but also *Penicillium* species were found. The intensity of the smell of mould varied from moderate to strong.

Fig. 1. The existing partition-wall construction is shown in the upper drawing. There is no thermal insulation under the reinforced part of the concrete slab, nor a moisture barrier under the sill and the strips of fibreboard. The principle of the operation on the partition wall is shown in the middle drawing above. The wall is opened up on one side. The mouldy sill has been removed. A metal plate prevents the sand from running out. The lower drawing shows how a steel sill has been placed next to the concrete slab. Above this there is a new wooden sill, a supporting sill and oak chocks glued to the wall joists in the bearing wall. The skirting board is somewhat higher than on the original wall – the only visible sign of the operation

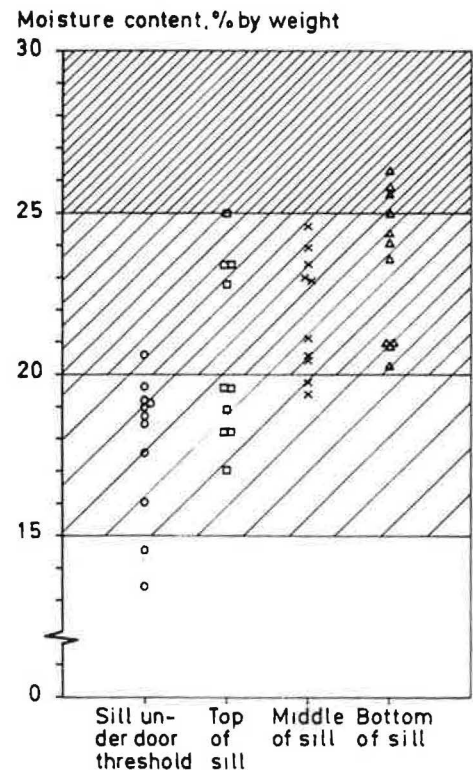
In tests carried out between February and June 1986 the moisture ratio in sills and the intensity of the smell of mould were determined in 12 buildings on each test occasion. The tests were restricted to sills under oak thresholds (entrance to kitchens) and lower wall sills. The results are shown in Fig. 2.

Fig. 2. Moisture content (%) in the sills. The slanting lines represent the risk of microfungoid attacks (also in Figs 3, 5 and 6).

As can be seen there was a risk of attack by mould fungi

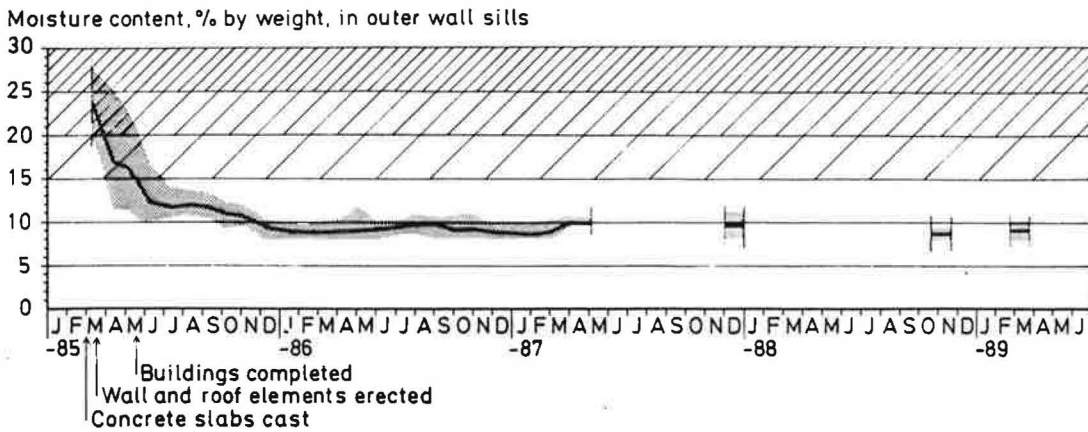
Fig. 3. The first building in which the new steel sill system was used in a new construction was an experimental building in Sigtuna, where new building components and other factors were studied (ref. 2).

Moisture content determined for outer wall sills (mean values and standard deviation for six measuring points) in this project are shown in this figure. The speed at which the buildings dried out is high and after only 2 to 3 months the moisture contents were below critical values. The mean value (with very little spread) is constant at under 10% by weight, in other words at a reassuringly low level

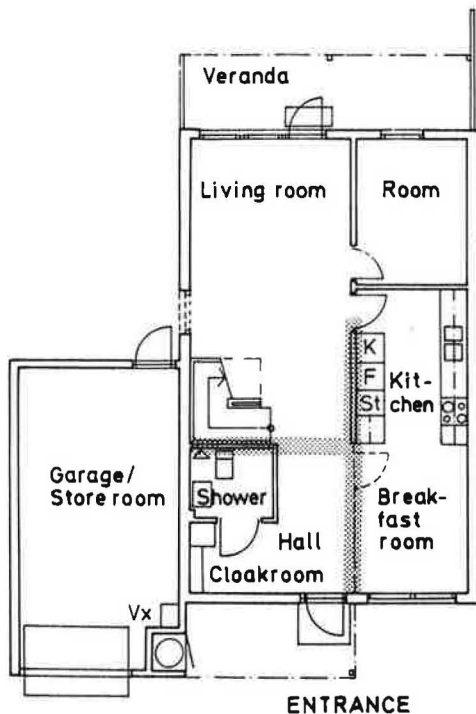
Fig. 4. Examples of one type of house plan. The reinforcements under the inner walls have been shaded in. As can be seen, adjacent to the partition walls are, for example, the living room and the bathroom and kitchen with a parquet floor and plastic floor covering respectively. It is expensive – using traditional methods – to break up these floors to get at the mouldy sills

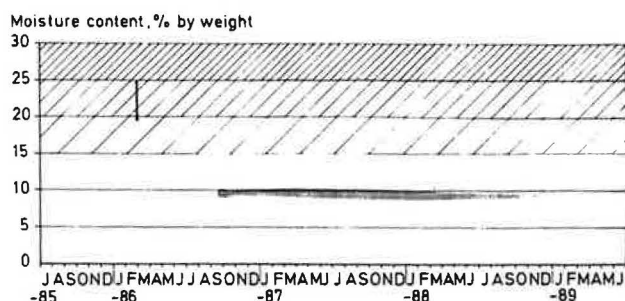
Fig. 5. Results of moisture content measurements in five buildings in which sills attacked by mould were replaced by steel sills and new wooden sills. The moisture content remained constant at a reassuringly low level. No mould attacks are possible (Fig. 7); there is no detectable difference between perforated and unperforated steel sills. The condition before renovation (indicated by first method) is also given in the figure for comparison

The new wooden sills dried out quickly on the steel sill system. The moisture content decreased from about 20% to <10% (Fig. 5). The moisture content also showed very little spread for the five buildings. There was no difference between perforated and unperforated steel sills. The moisture content has since stabilized at this low level. Where the alternative method using fungicide/ozone treatment was employed, the wood dried out when the wall was opened up. The moisture content then rose again to the original level, i.e. the moisture content lay close together at about 15–16% in the buildings that were studied (Fig. 6).

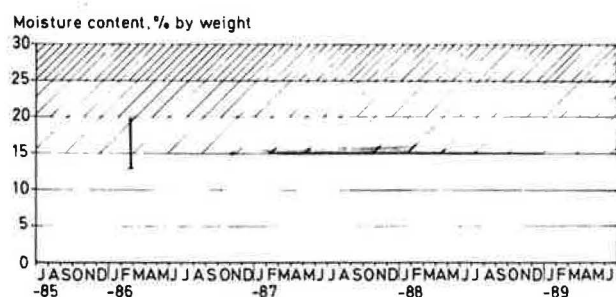
Fig. 6. Results of moisture content measurements in three buildings where renovation consisted of chemical treatment of the existing sills and the removal of smell by ozone treatment. When the wall was first opened up, the sills dried out; but after a while the moisture content rose to about the same level as before renovation. This is quite natural, since the moisture transfer from below has not been interrupted. The fungicide treatment, however, does prevent the growth of mould. The question is: for how long? Unfortunately the inhibiting effect of the fungicide has a tendency to weaken over the years

The alternative method using mitrol and ozone treatment also gave satisfactory results; the highest moisture content measured, 16.5%, is not sufficient for the development of the commonest types of mould fungi. Spraying the sills with mitrol also provides extra protection against attacks from airborne mould spores which may reach the wood surfaces through small gaps. It was, however, possible to detect a slight smell of mitrol about 2½ years after treatment, when the observation holes were opened.

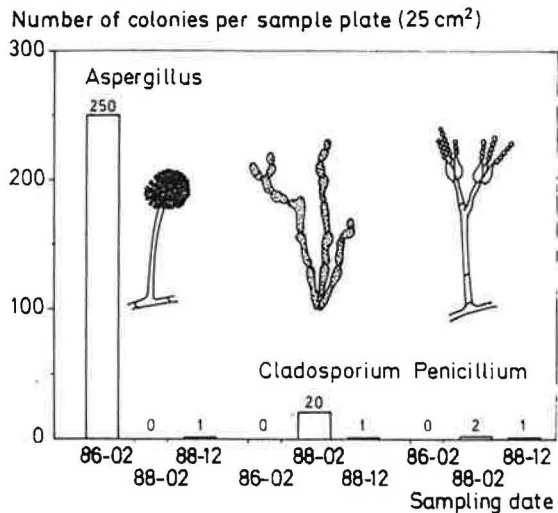
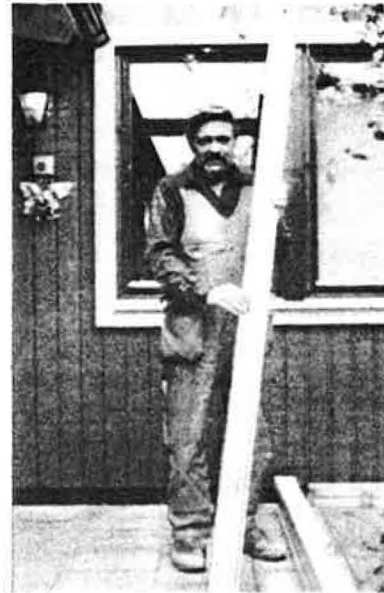
Fig. 7. Examples of results from one of the buildings where the original wooden sills were replaced by a steel sill to the right, and a new wooden sill.

The original wooden sill had been badly attacked by Aspergillus. After the steel sill had been laid, the conditions favourable to the development of fungi were completely eliminated.

The temporary growth of Cladosporium (20 colonies) in February 1988 has decreased in the sample taken in December 1988 by 19 colonies; i.e. the risk of any further growth of Cladosporium can be considered non-existent.

The presence of Penicillium was low both before and after laying the steel sill. Only occasional colonies were found in the samples.

Thus it is quite evident that by laying the steel sills the conditions favourable to the development of the commonest types of mould fungi were eliminated) i.e. the moisture content in the overlying wooden sill is far below the critical level of moisture, (fig. 5). The safety factor is high. It is therefore possible to guarantee high-quality building standards
