# BULLETIN

APRIL 1994

NUMBER 319

## SUBFLOOR VENTILATION

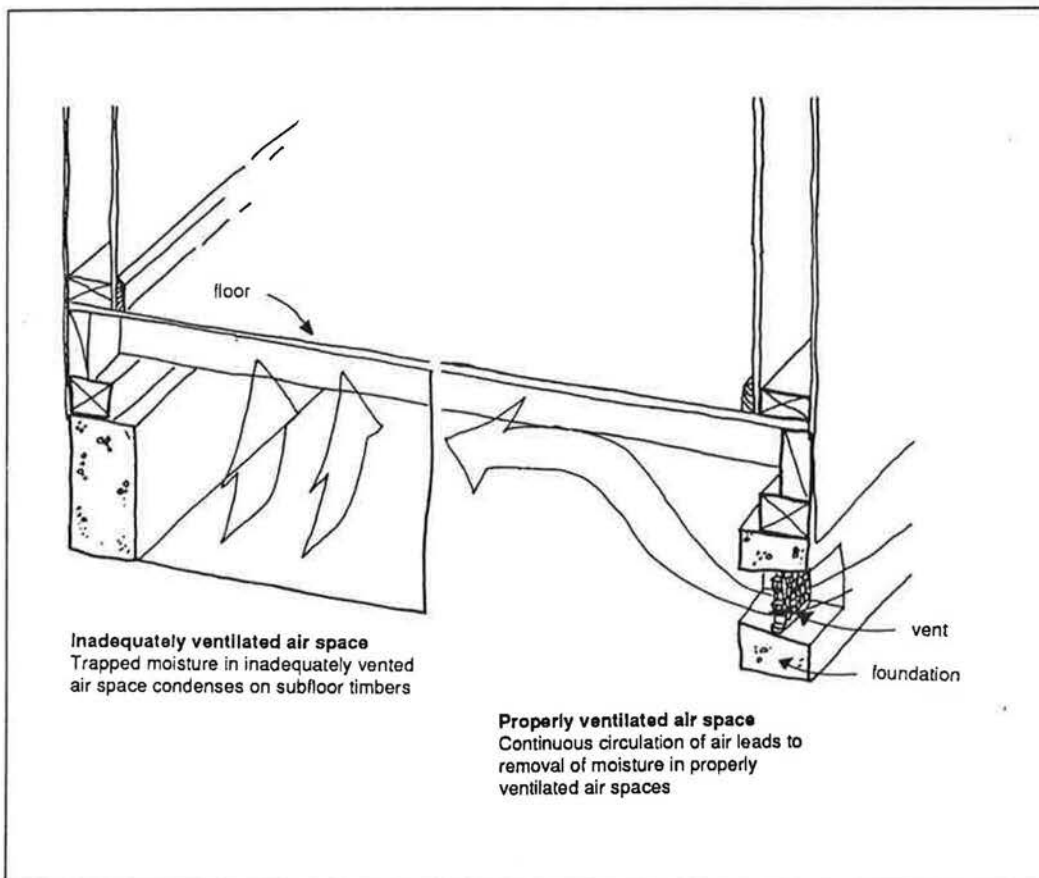
**Figure 1 Ventilate to Prevent Moisture Damage**

The major cause of this increase in moisture content is prolonged high moisture levels in the subfloor air and occasional or frequent condensation on cold subfloor supporting timbers or the cold underside of floor decking resulting from restricted, blocked or poor subfloor ventilation.

Good ventilation (Figure 1) of the subfloor space under the building is the most effective way to remove moisture present and keep the moisture content of the timber structure at safe levels.

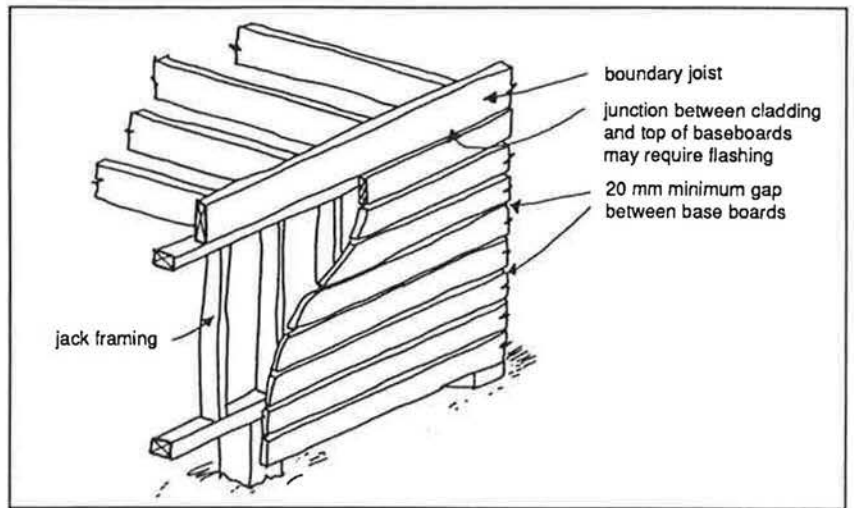
Figure 2 Base Boards

around the perimeter of the buildings subfloor area. This method usually meets the Code requirements with ease. (Figure 2)

Open base boarding (Figure 2) is another common and very effective way of providing airflow below suspended floors. It is often used in buildings which have corner foundation walls together with perimeter piles or those buildings totally supported on piles.

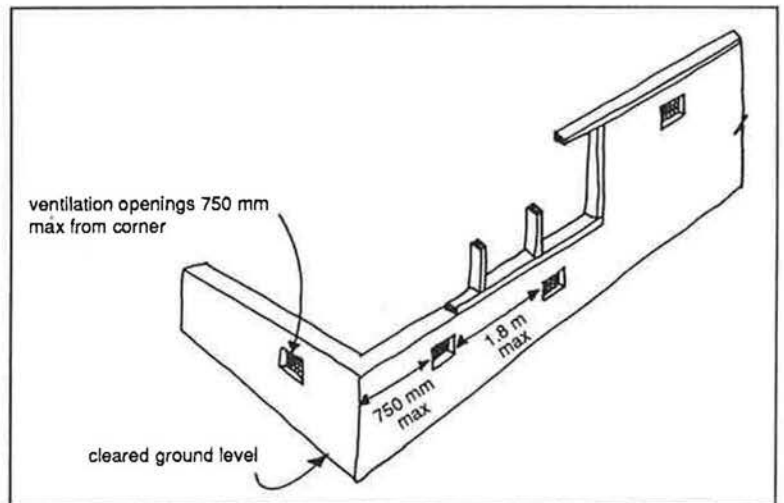
Figure 3 Foundation Wall Ventilators

- wall ventilators, spaced at 1.8 m maximum centres around the perimeter of the building to provide the required amount of clear ventilation area. A ventilation opening must be provided within 750 mm of each building corner. The net open area of a ventilator must be no less than 50% of the gross ventilator area. (Figure 3)

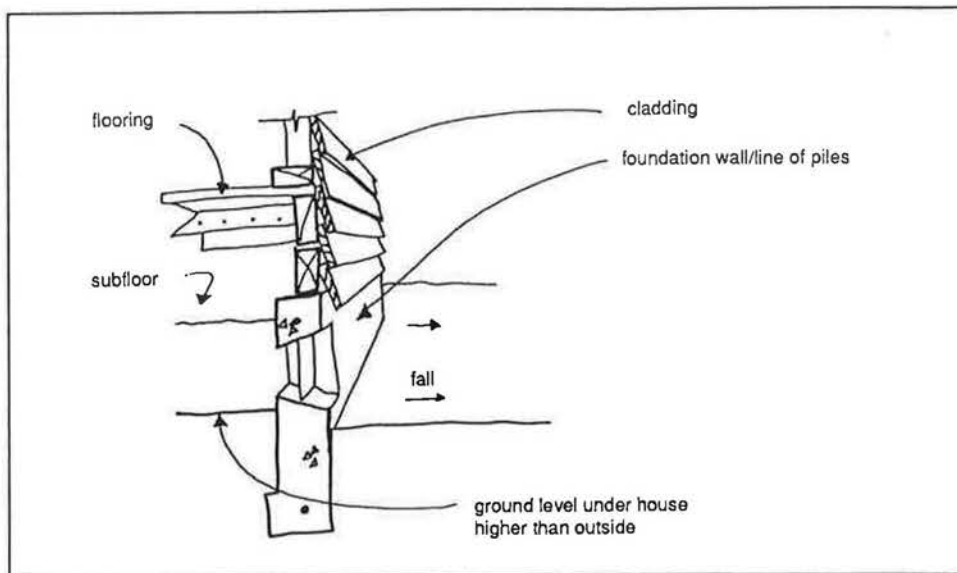
**Figure 4** *Draining Surface Water Away From the Subfloor Space*

The area around the building should be graded to prevent water from accumulating under it. The land immediately around the building must be lower than subfloor levels and should slope away from the walls for at least 1.0 m to drain water away from the foundations. (Figure 4)
