An innovative passive system for preventive conservation of the ancient stained glass windows in the Assisi's St. Francis Basilica Superior Church

A. Mingozzi and S. Bottiglioni

Ricerca & Progetto - Galassi, Mingozzi e associati, Bologna, Italia

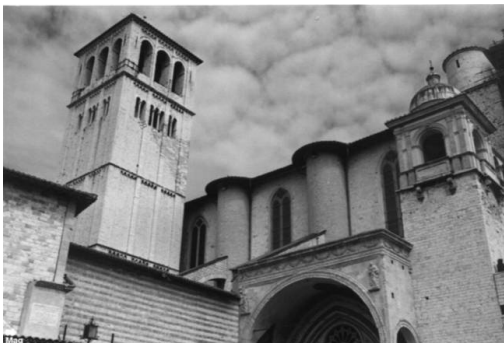
Figure 1: St. Francis Basilica Superior Church in Assisi (south oriented façade).

The magnificent *Corpus Vitrearum* of St. Francis' Basilica in Assisi (Italy) is one of the most important and oldest in the world, dated from the 13th century (Figs. 1 and 2). A number of windows constituted by stained glasses illustrates biblical stories and saints lives.

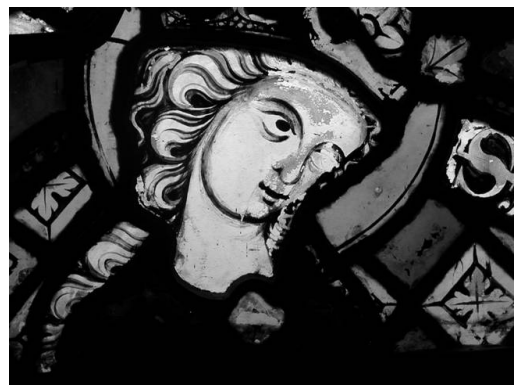
Figure 2: Detail of a XIII century stained panel from window IX.

Ancient stained glasses are a complex mosaic of pieces of coloured glass. They are decorated following the medieval technique of grisalles and joined with lead into an intricate pattern that gives as result a sort of translucent picture.

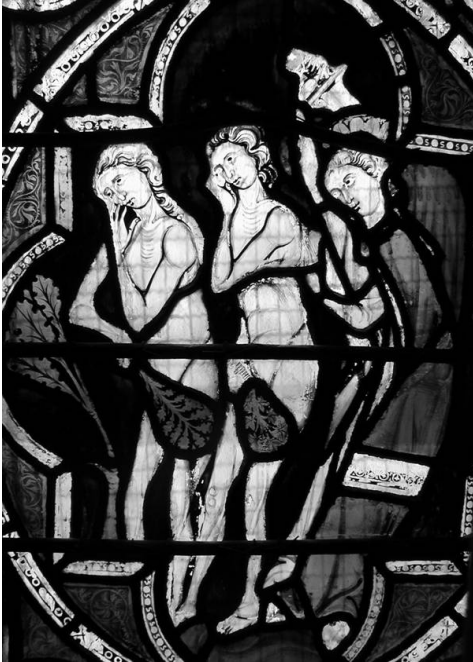
Figure 3: Detail of a XIII century stained panel from window IX; the external protection metal net of the old protective system affects visual perception.

Such windows, basically constituted by an iron made frame, single glass pane and a metal net, created a sort of external barrier which have affected the ancient glass perception, without providing an effective climate control (Fig. 3).

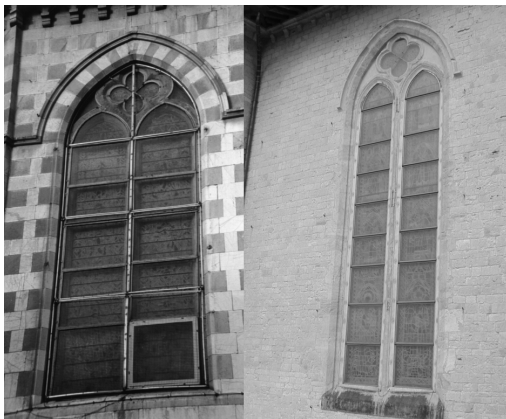
Figure 6: Old protective glazing system and new passive system installed in two different windows with the same orientation.

The new external glazing protective system is made of an iron painted frame and the glass is of polycarbonate specially treated on surface. Polycarbonate doesn't produce any reflections, doesn't affect daylight, provides UV protection and moreover is light weight, safe and easy to be mounted and substituted (Fig. 6).

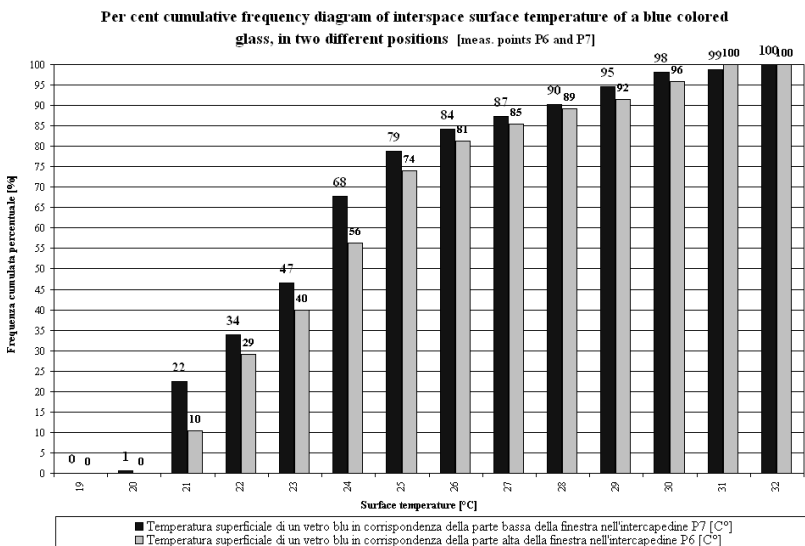
Figure 9: Per cent cumulate frequency diagram.

For this purpose “deviation indicators” for the required parameter (ex. T, R.H., etc.) have been calculated. Such indicators permit to calculate the time percentage in which monitored values differ from the acceptance range of the parameter. This can be easily done looking to “per cent cumulate frequency diagram” (Fig. 9), calculated for the reference period (possibly on

an hourly basis). With such representation we can decide to accept a deviation from the expected values when it appears for short time.
