FIELD MEASUREMENT TESTING OF AIR TIGHTNESS – EXAMPLE FROM A HOSPITAL PROJECT IN SWEDEN

Erik Olofsson Augustsson^{*1}, and Fredrik Karlsson¹

1 Sweco Systems AB

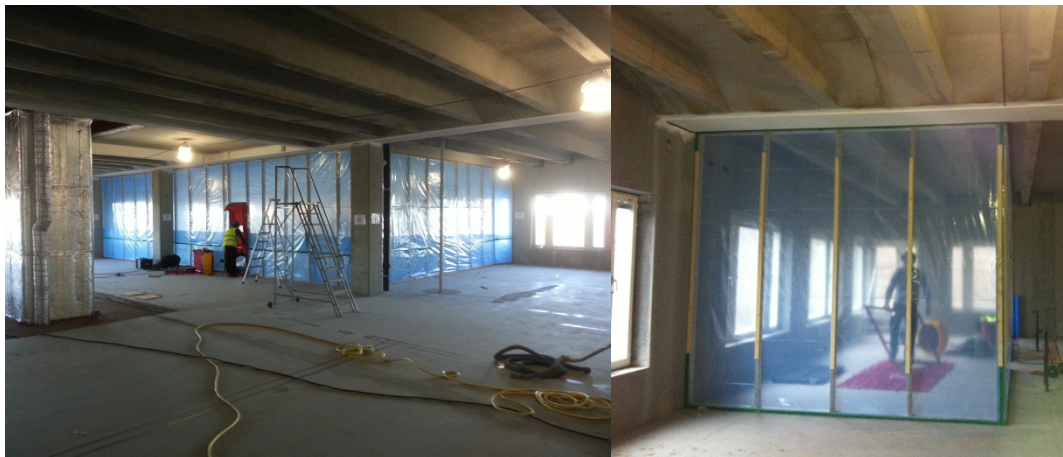
As shown in Figure 1 below the constructor built temporary walls to divide the floor. The box was then depressurised to 50 Pa with the Blower Door equipment and search for leaks with infrared camera and Regin Smoke bottle (RFA 10) was performed.

Figure 1. Different temporary boxes made with a stud frame and plastic film for early stage testing

It is very important that the box is made as air-tight as possible. During the first test it was a lot of leaks in the box. Important things to get the box as air-tight as possible are to use a flexible multi-purpose adhesive tape everywhere where the plastic film meets another material and where the plastic film is overlapping. It is also important that there is a butyl-based adhesive strip under the floor joist, at the corners and under the ceiling joist.

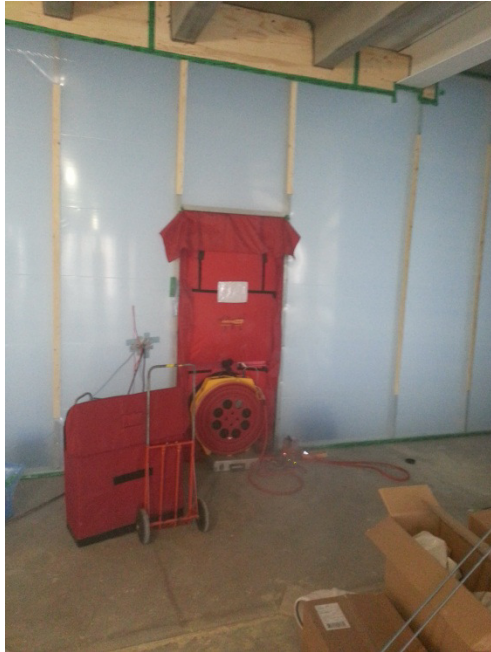
When pressurising the temporary boxes it has been very effective to fill the box with smoke and to search for leaks from outside the building envelope. To have both the building workers and the design team present during these tests has been very pedagogical for everyone. Figure 2 shows a temporary box that is filled up with smoke. In Figure 3 the smoke is finding its way out through the wall, indicating air leakage.

Figure 2. Temporary box filled with smoke for early stage testing and to identify leakage sources from outside of the building

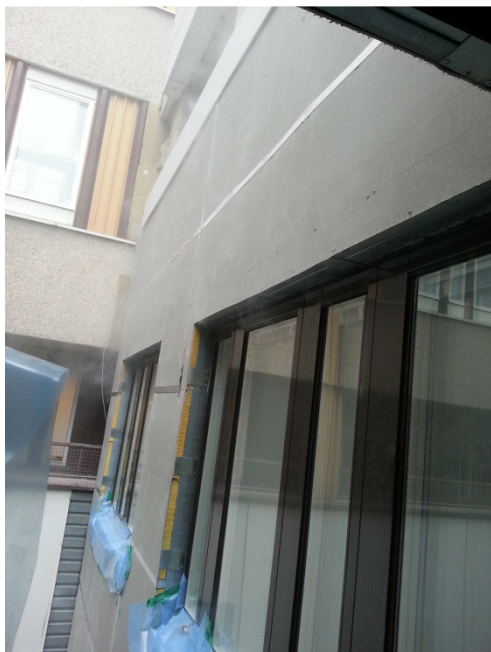
Figure 3. Smoke coming thru the outer wall and connection to existing parts of the hospital during pressurising test at +50 Pa.

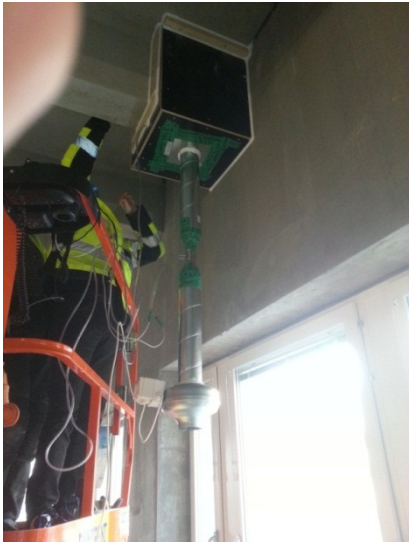
One result of the early measurements was that there was an air leakage in the connection between ceiling and outer walls (Figure 5 below). As this was a common part of the building a program for measuring the air-tightness for this part was developed. The measurements equipment was including a box that was mounted to the ceiling. The box was connected to a duct with a fan (Figure 4 below). The air-flow pressure was measured and the air-flow was changed by the fan.

Figure 4. Equipment used for measuring air-leakages in ceiling along the outer walls

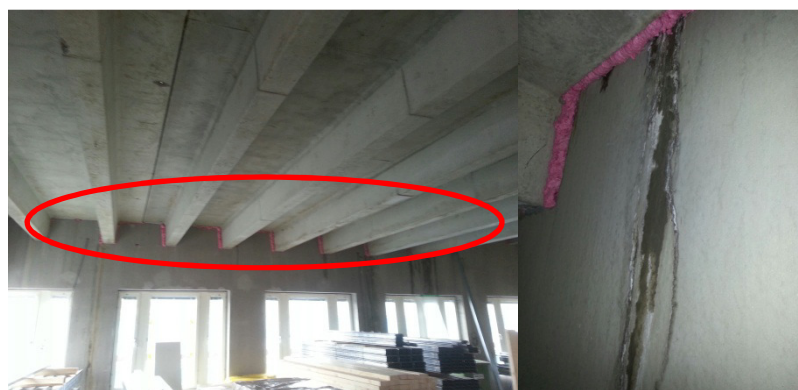
After that the construction was sealed with air-tight foam (see Figure 6 below) two new tests were performed, resulting in a very low air-infiltration rate (see Table 2 below).

Figure 6. Ceiling along outer walls after sealing with air-tight foam

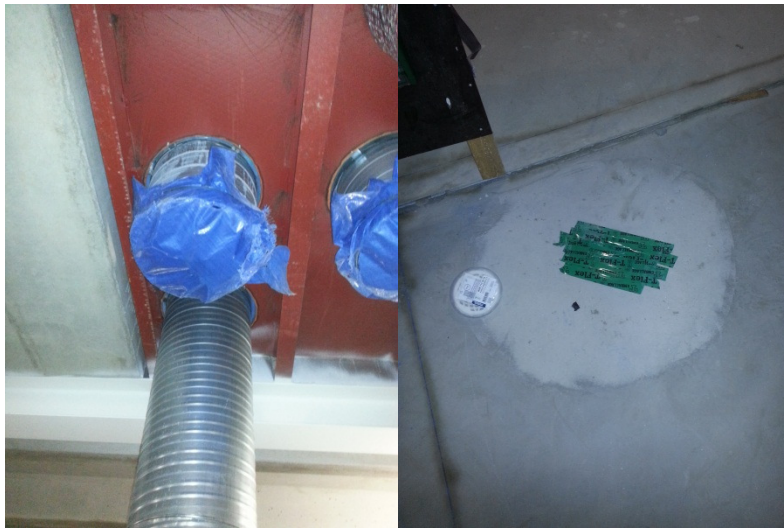
The measurements of whole floors were indented to measure the air permeability of a whole part of the building to check compliance with the airtightness specification. One floor is about 1500 m². As the test was adjusted to the building process inner walls was not finished and there were still some outer constructions that was not air-tight during the measurement. Thus, several temporary seals with foam and tape were used. For example, ducts, floor drains and shafts were sealed (Figure 7).

Figure 7. Temporary seals between different floors (ducts and floor drains)
