SOME PRACTICAL ASPECTS ON THE INFRA-RED
THERMOGRAPHY OF BUILDINGS

by J. B. Siviour

OCTOBER 1981

THE ELECTRICITY COUNCIL RESEARCH CENTRE,
CAPENHURST, CHESTER. CH1 6ES

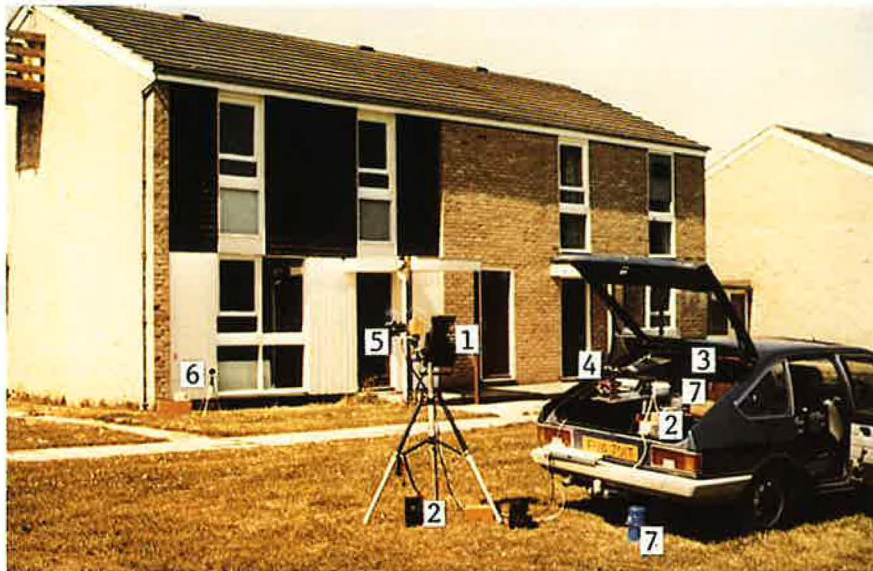
FIGURE 1 ON SITE WITH THE IR CAMERA AND ASSOCIATED EQUIPMENT

- (1) Infra-red camera* and tripod
- (2) Battery or mains electric supply
- (3) Colour monitor
- (4) Camera for colour picture in IR radiation
- (5) Camera for picture in visible radiation
- (6) Black body reference temperature
- (7) Liquid nitrogen flask and box

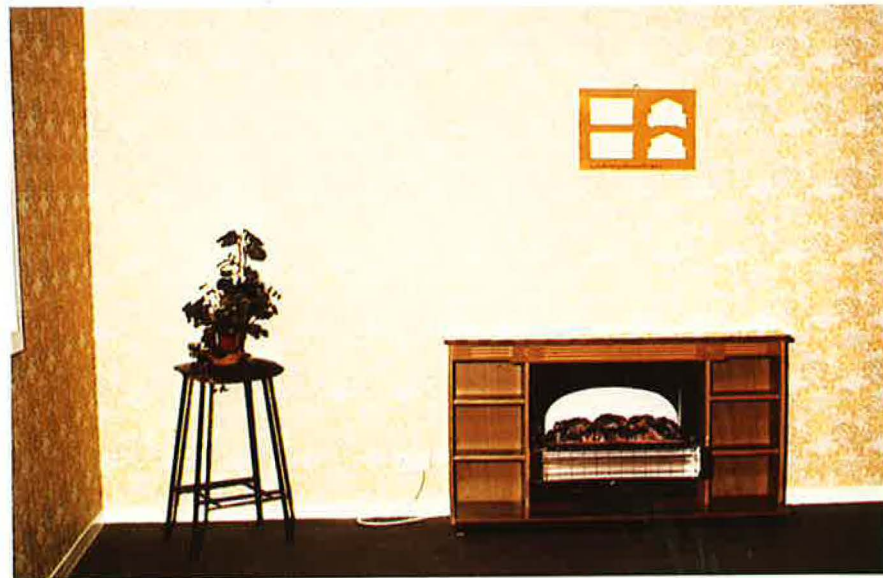
FIGURE 3 LIVING ROOM VIEW IN INFRA-RED AND VISIBLE RADIATION. THE HEATER IS OFF AND ALL SURFACES LIE WITHIN THE 5 K RANGE, FROM THE COLD CORNER (BLUE) IN THE LOWER LEFT THROUGH GREEN, PURPLE, WHITE AND A RED PATCH ABOVE THE HEATER WHICH IS WARM BECAUSE OF THE LIGHTING ARRANGEMENT

heater. With the heater off a range of 5 K brings in all five colours in the IR picture to show considerable temperature non-uniformity. With the heater operating and the range set to 500 (Figure 4a) the wall and the heater surround have a much more uniform colour, with only the glow bar and immediate surroundings taking different colours. Reducing the range to 200 (Figure 4b) identifies a warm patch on the floor.

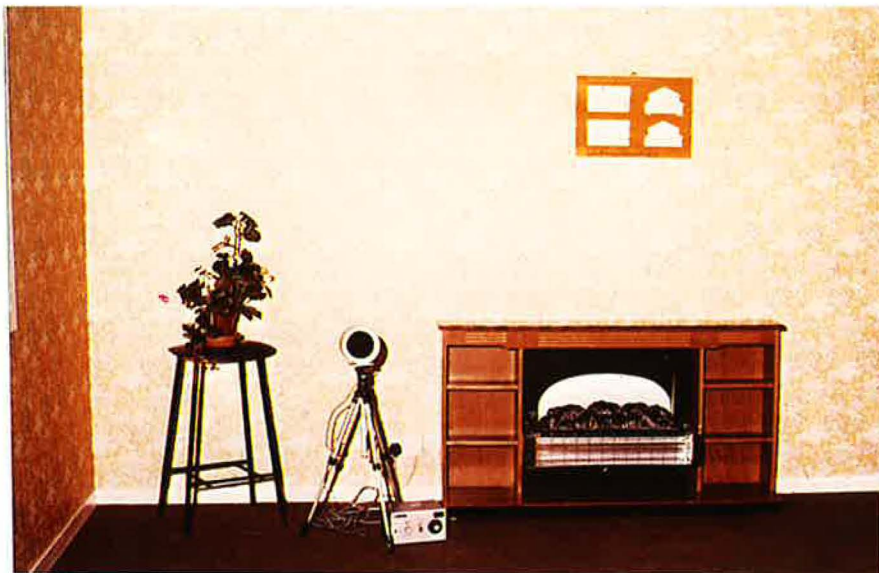
FIGURE 5 USE OF A REFERENCE TEMPERATURE TO DEFINE THE TEMPERATURE LEVEL. THIS IS A REPEAT OF FIGURE 3 BUT INCLUDING A KNOWN REFERENCE TEMPERATURE. IT IS JUST IN THE RED COLOUR BAND SO THAT ITS TEMPERATURE IS AT THE WHITE/RED CHANGEOVER.

To specify accurately the temperature range, the manufacturer's calibrations must be used at each temperature level. To set the temperature level a known reference temperature has to be included in the picture - Figure 5. An adjustable isotherm facility is useful in defining where the reference temperature is on the scale - Figure 6.

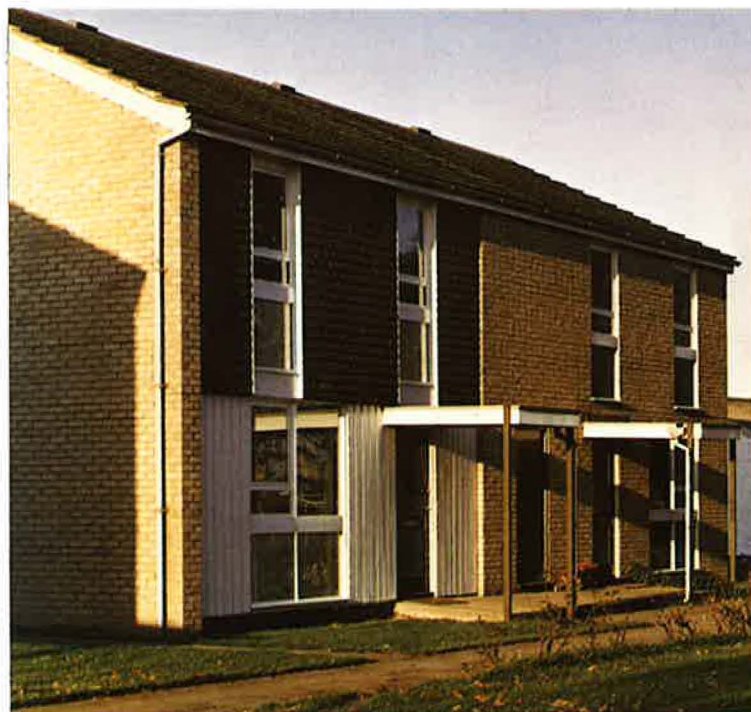
FIGURE 8 VIEW OF TWO HEATED HOUSES IN INFRA-RED AND VISIBLE RADIATION. THE ONE ON THE LEFT IS WELL INSULATED (DOUBLE GLAZED AND WALL $U \approx 0.5 \text{ W/m}^2\text{K}$) AND THE ONE ON THE RIGHT POORLY INSULATED (SINGLE GLAZED AND WALL $U \approx 2.0 \text{ W/m}^2\text{K}$). THE INFRA-RED PICTURE WAS TAKEN 4 HOURS AFTER SUNSET, BUT THE RESIDUAL EFFECT ON THE GABLE WALL OF THE INCIDENT RADIATION IS SHOWN BY THE PURPLE AND WHITE COLOURS. OTHER POINTS DISCUSSED IN THE TEXT ARE THE RED STRIPS AT THE TOP OF THE WINDOWS AND THE UNIFORMLY BLUE ROOF.

A number of external views of buildings are shown in Figures 8 to 11, taken in visible light and IR radiation. The first (Figure 8) shows a pair of semi-detached houses heated inside to about 15 K above the outside temperature. The house in the left hand side of the picture is well insulated with double glazing and insulation thicknesses in the walls of 50-100 mm ($U\text{-value} \approx 0.5 \text{ W/m}^2\text{K}$). The house on the right hand is uninsulated having single glazing and solid external

walls of 9 inch brick ($U\text{-value} \approx 2 \text{ W/m}^2\text{K}$). The IR picture has five colour bands each representing approximately 1 K at the levels 8 to 13°C.

The colours follow generally the expected pattern. Most of the external surface of the front wall of the insulated house is green, which is a colour cooler than the purple of the uninsulated house. The blue replacing the green in the left hand corner suggests a borderline temperature of 8/9°C, possibly caused by cold outside air circulating behind the cladding. In this house the lower sections of the windows have been insulated to a similar level to the rest of the front wall as shown by the colour. The colour green suggests surfaces 2 K warmer than outside, and purple 3 K warmer. Temperature differences calculated using the U-values are considerably less at 0.4 K and 1.6 K respectively.

The surfaces of most of the double glazed windows are purple and white compared with white and red for those windows which are single glazed. The exceptions are red strips at the tops of the two upstairs, openable, double glazed windows. An explanation is that warm air is leaking out from inside.

The gable wall is insulated, yet its colours of purple and white indicate temperatures higher than the purple alone of the solid brick wall of the uninsulated house, suggesting that the gable wall is not insulated. The explanation is the residual effect of the sun. The IR photograph was taken about four hours after sunset on a sunny November day. The ordinary photograph was taken mid-afternoon on that day and shows clearly the sun shining on the wall.

The roof shows uniformly blue and thus cold, and therefore appears to be uniformly well insulated. In fact the loft insulation was 300 mm thick in the insulated house compared with only 20 mm thick in the other. What is being registered by the IR camera is a reflection of the cold night-time sky and the radiation from the edges of the roof tiles which are exposed to the external air.

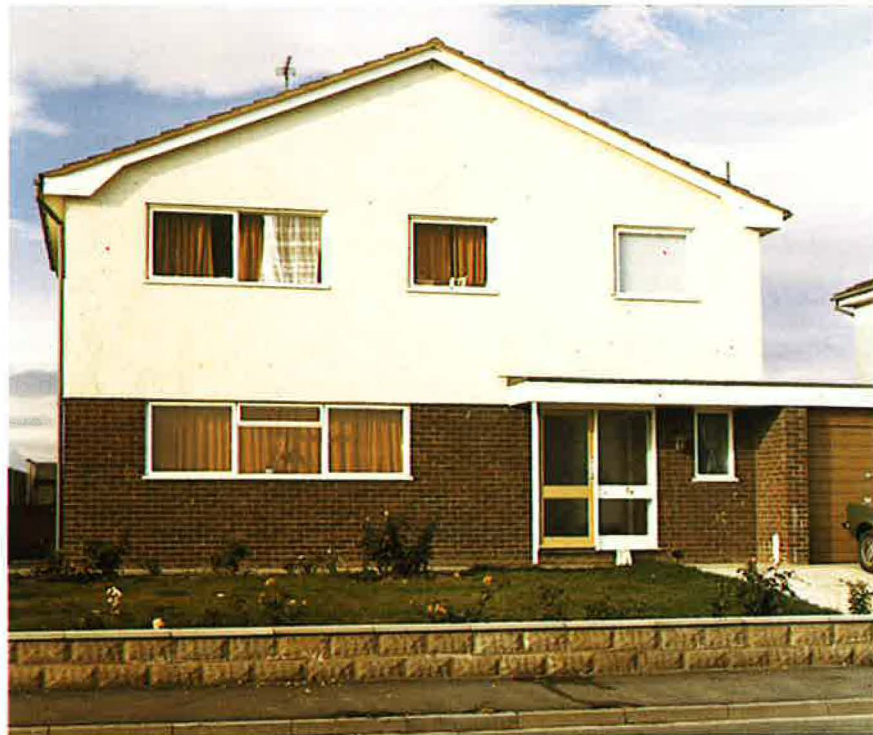
FIGURE 9 SINGLE GLAZING (UPSTAIRS) AND DOUBLE GLAZING (DOWNSTAIRS) SHOWN BY THE COOLER OUTSIDE SURFACES OF THE DOUBLE GLAZING WITH UNIFORM TEMPERATURES INSIDE. A SIMILAR IR PICTURE WOULD BE OBTAINED FOR ALL SINGLE GLAZING IF THE DOWNSTAIRS ROOMS HAD A TEMPERATURE ELEVATION ABOVE THE OUTSIDE OF ABOUT TWICE THAT OF THE UPSTAIRS ROOMS, FOR EXAMPLE, 10°C OUTSIDE, 20°C DOWNSTAIRS AND 15°C UPSTAIRS.

Another comparison of double and single glazing is shown in Figure 9. The outer surfaces of the double glazing are cooler than those of the

single glazing with the house heated to a uniform temperature throughout. A similar picture would be obtained with single glazing throughout if the temperature downstairs was warmer than upstairs as suggested in the caption to the figure.

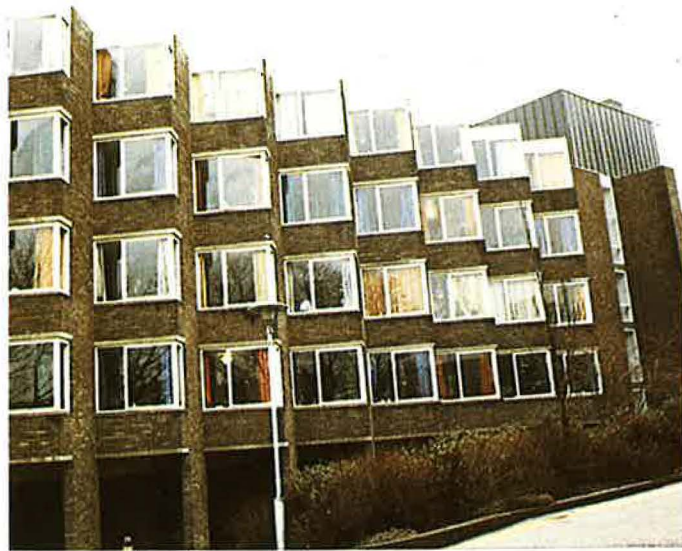
FIGURE 10 HOT SPOTS A AND B IN THE INFRA-RED PICTURE ARE CAUSED BY ELECTRIC LIGHTS THROUGH THE GLASS

Room lighting through glass windows is registered as warm areas in the IR of Figure 10. Such imaging could be interpreted wrongly since double glazing could have the warmer appearance obtained with single glazing.

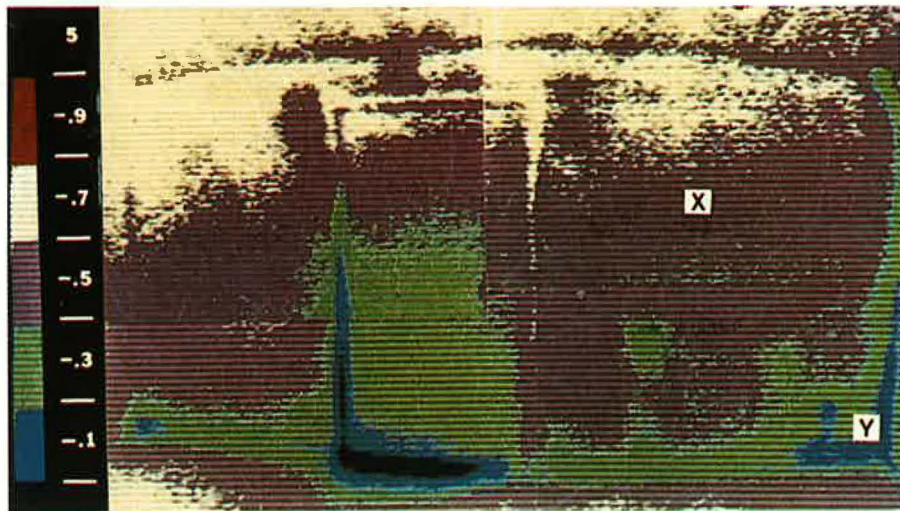
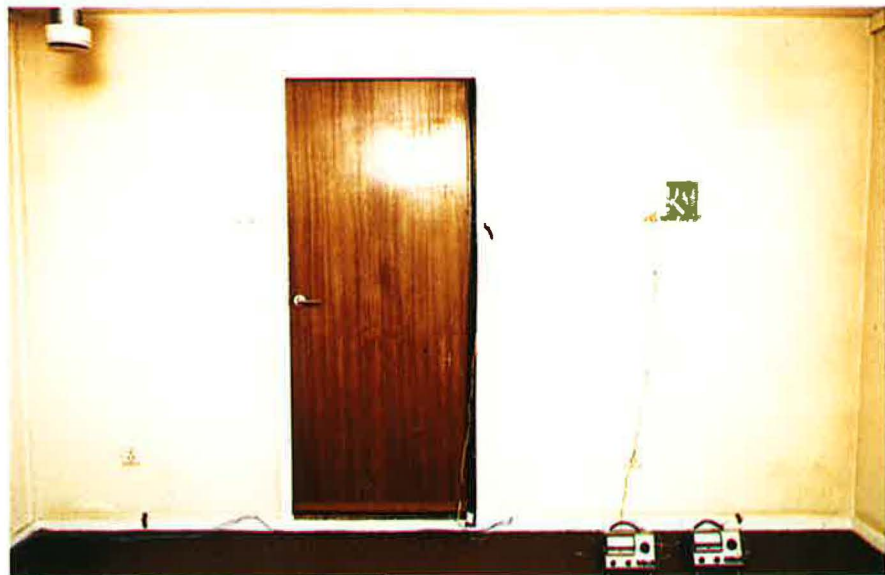
FIGURE 12 PHOTOGRAPHS IN INFRA-RED AND VISIBLE RADIATION OF THE INSIDE SURFACE OF AN EXTERNAL INSULATED WALL ($u \approx 0.6 \text{ W/m}^2\text{K}$). EACH COLOUR BAND REPRESENTS 1 K DIFFERENCE. POSITIONS ARE SHOWN FOR MEASURING REPRESENTATIVE (X) AND LOCAL (Y) HEAT FLOWS USING THE EQUIPMENT SHOWN IN THE ORDINARY PICTURE. BLACK APPEARS AT THE BOTTOM OF THE DOOR IN THE IR PICTURE SHOWING A TEMPERATURE COOLER THAN THE SET SCALE.

Infra-red thermography can be used internally possibly with greater precision than externally but perhaps less dramatically. Figure 12 shows an ordinary and IR photograph of an external wall of a room with a door into an external porch. This wall has been subjected to numerous heat flow measurements, although the ordinary picture shows no temperature irregularities. The IR picture however shows significant variations of 3 K with four colours (blue, green, purple and white) represented, each colour band representing about 1 K. This picture had to be made from four separate photographs because the room was too shallow for the lens angle to cover the whole wall in one exposure. Lines showing the joins can be seen. Care was taken to keep the temperature level constant and to take the photographs in quick succession so that for all of them the same colour represented the same temperature.

Generally, the wall temperature increases with height through about 2 K (green to purple to white). A representative position (X) is marked in the purple where heat flow through the wall was measured⁽²⁾. Apparent cold spots are shown blue, around the door due to air infiltration, and in the lower right hand corner (at Y). It is important to measure heat flows at cold spots such as Y because they may not be places where local heat flows are high, but where cold outside air is infiltrating, which would reduce local outward heat flow. Cold spots D arise from the plaster dabs fixing the dry-lining to the wall.

To compute accurate U-values from the IR picture would need accurate values of local air and radiant temperatures 100-200 mm from the wall. These temperatures would have to be measured in different positions vertically, because it is almost certain that at least the air temperature would have a similar vertical gradient to the wall temperature. Then taking a heat transfer coefficient for the inner surface ($8 \text{ W/m}^2\text{K}$) from the CIBS Guide⁽³⁾ heat flow can be calculated. The U-value would then be derived by dividing this heat flow by the inside to outside temperature difference. This IR method for assessing heat flow has not been used, instead the heat flow has been measured directly. This is easier than measuring local temperatures, especially when the IR camera is in use at the same time.
