# Fan Design & Applications

## PUBLIC TRANSPORT GARAGE (PARKING AREA) VENTILATION

I. J. Cockram and J. F. Bearman

London Transport Executive, U. K.

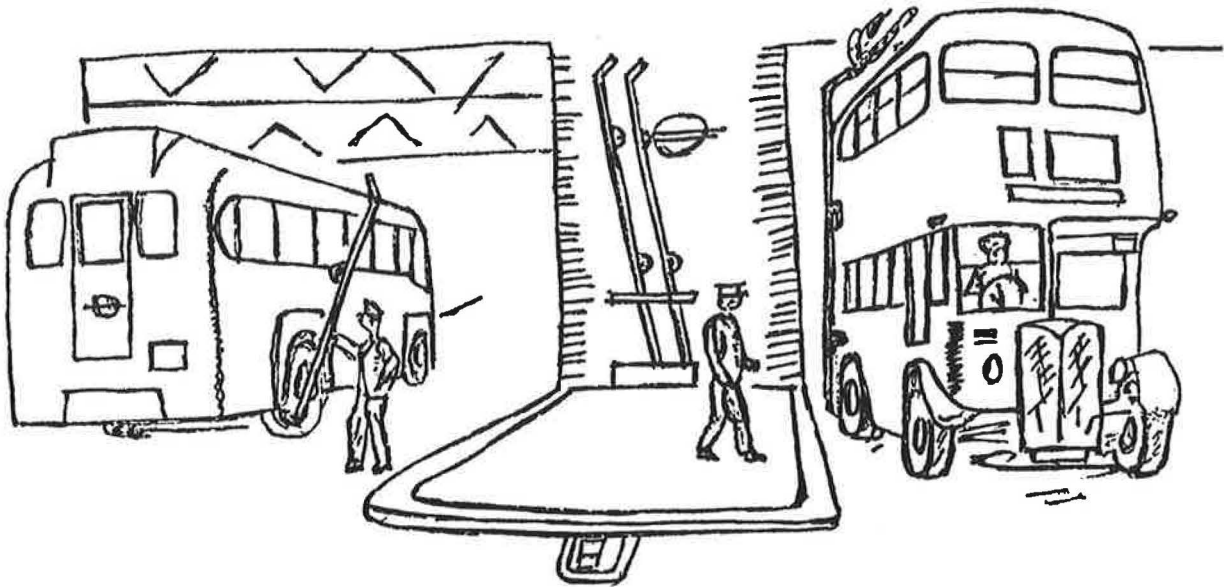
Fig. 2

1. Detachable exhaust extensions attached on entry to garage with suction pads or magnets.
2. Roof bay partitioned to act as collection hoods.
3. Roof fans.

The Factory Inspector's report stated that it was generally agreed that the 'fumes generated' were offensive, whilst hinting that although they could not strictly be proved to be actionable, it might be a gesture to do something and offered a suggestion as to what that 'something' might be ..... Figure 2 refers.

Having said all this, let us take another look at the Factory Inspector's proposal for Sutton ..... Figure 2 refers. Should buses discharge their exhaust at ground level? Perhaps this is another legacy from the horse buses! Although there are problems associated with the extension of the exhaust pipe to discharge at roof level, insulation, access, height clearance and the possibility of bodywork/window 'streaking', the difficulties are not insuperable. Our Bus Engineers have not therefore entirely rejected the suggestion for the next generation vehicle.

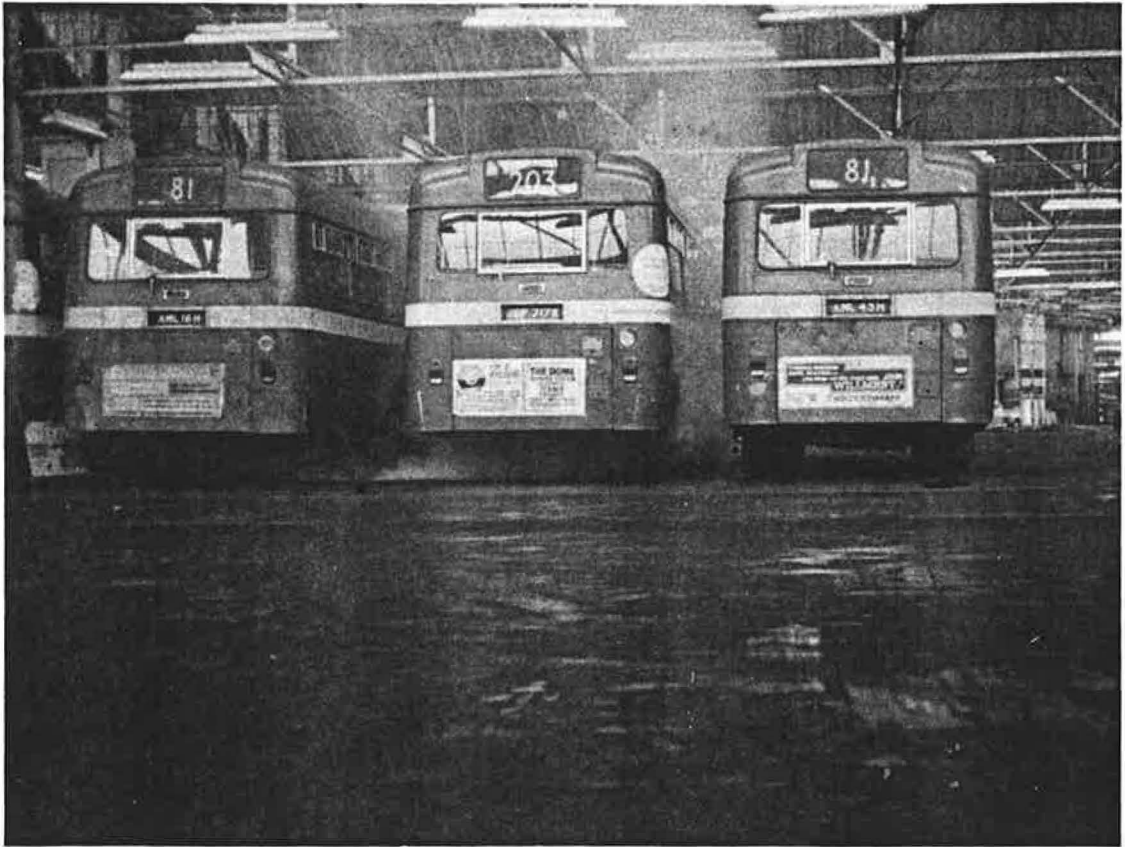
Fig. 3 Hounslow - chimney effect

In association with the calculations, some experiments were conducted to see what happens to 'exhaust' after it leaves the bus tail pipe ..... Figures 3 & 4 refer. Observations were made at a number of garages - it was considered essential that to get the 'feel' of the operation, the Design Engineer should attend before the start of the 'run-out' and observe the whole procedure.

From the experiments it was deduced that the chief force affecting the gases was 'buoyancy', which takes effect as the tail pipe velocity decays. By installing a fan in an inspection pit and forming an 'adjustable-slot' at garage floor level, attempts were made to determine if there was a 'practicable pick-up velocity', to capture the fumes in underfloor ducts - thus avoiding them passing through the 'breathing zone'. Inlet velocities of up to  $10.16 \text{ ms}^{-1}$  were tried, but in each case the bulk of the discharge escaped collection.

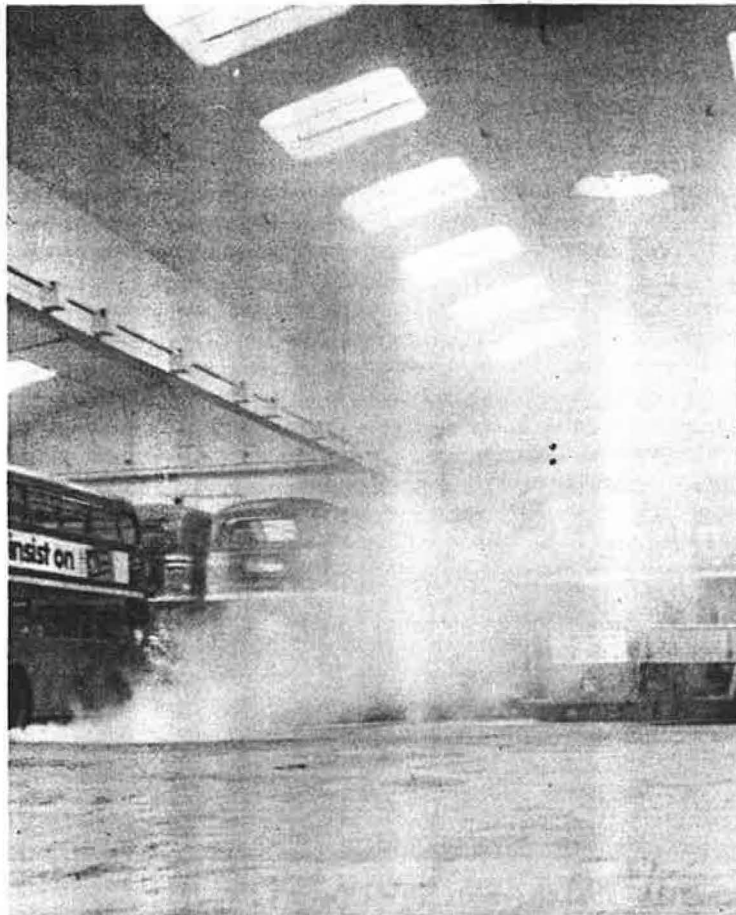
Fig. 6 Peckham garage - parking area - new ventilation scheme

The installation went into service in August 1973 and the series of photographs ..... Figures 6 & 7 refer, show the effectiveness, during a morning 'run-out' - in early 1974. The results were generally satisfactory.

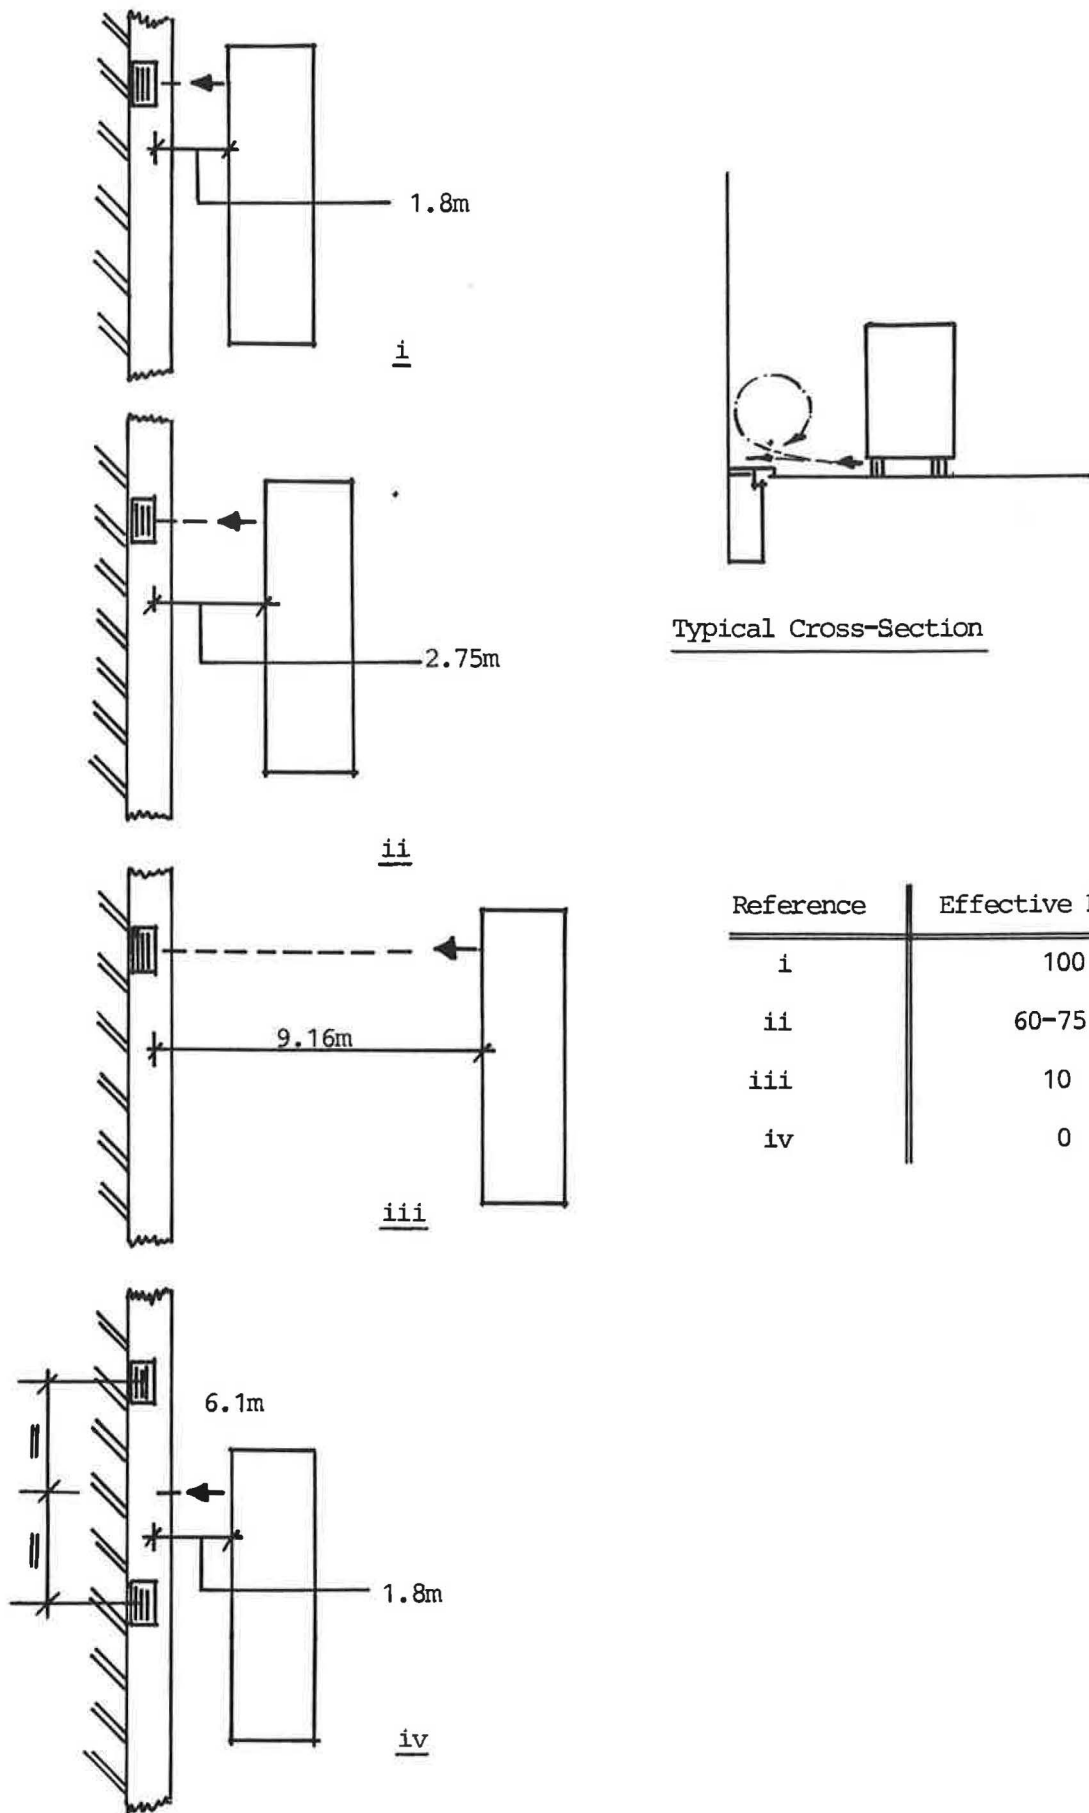
Typical Cross-Section

Reference	Effective Pick-up %
i	100
ii	60-75
iii	10
iv	0

Fig. 10 Underfloor parking area ventilation - test positions of buses

The diagram ..... Figure 10 refers, shows the results of tests, carried out with a bus at varying distances from a grille. It will be noted that the overall 'extraction' is reasonably good, due to the grille being adjacent to the end wall and any fumes missing 'direct pick-up' at the grille are ultimately extracted through a general air movement - the photographs illustrate this quite well. It is considered that if the grilles were in the centre of the Parking Area, the fumes would pass through the 'breathing zone' twice - this effect is obviously worse than the high level extraction position, where only one 'pass' is made.

The installation is only effective very close to the grilles because of the very high volumes passing through them, giving a correspondingly high pick-up velocity. Volumes on this scale could not be provided at the required 'pitch' in a garage without introducing prohibitively high quantities of fresh air and the use of excessive fan power, as well as the adoption of fixed parking positions for buses.
