Radon in Homes: The Alaska Experience

By Richard Seifert

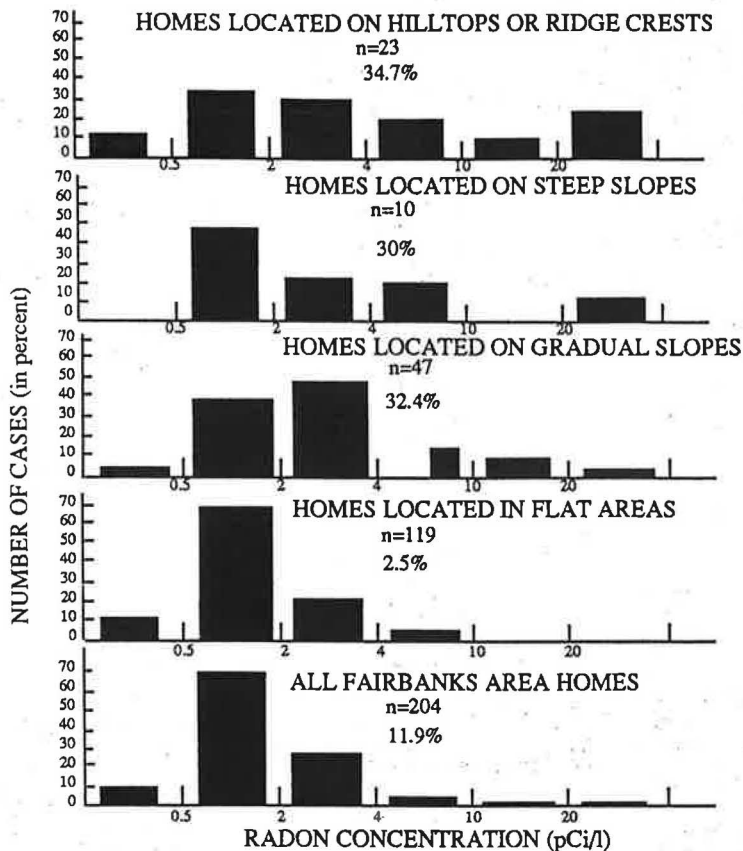
Figure 1. Histograms Summarizing Radon Measurements and Local Geography of Fairbanks Homes

Along with the confirmation of these radon risk characteristics, the Alaska/EPA survey found that Interior Alaska has the highest proportion of homes with elevated radon concentrations as well as the individual homes with highest concentrations. In the Interior, 3% of homes within the sample population had screening levels higher than 20 pCi/l and 17.6% of homes had radon screening levels that were higher than 4 pCi/l. Figure 1 summarizes the home site geographic information which was included with the report of test results. This figure shows that 30-35% of homes built in the hills around Fairbanks have elevated radon concentrations.

"In the Fairbanks area, homes built in the surrounding hills with concrete slabs or basements in contact with bedrock yielded the highest radon levels. These areas also had the highest proportion of homes with basements in contact with the bedrock that did not have elevated radon concentrations. The data shown in Figure 1, for homes located on hillside sites, includes homes which

are built on thick accumulations of windblown glacial silt (loess). Thick accumulations of loess appear to be an effective barrier to radon movement. Homes built on alluvium from the Tanana and Chena Rivers are also much less at risk. High radon concentrations in homes in contact with bedrock are likely to result from high fracture permeability of the bedrock as well as relatively high uranium concentrations in the schist which comprises local bedrock. Low radon concentrations in homes built on loess and alluvium may reflect low soil gas permeability, low uranium concentrations of soils, or both." (Nye and Kline, 1990).
